CNOOC UGANDA LIMITED

Visual Impact Assessment Report for the Proposed Kingfisher Development

Report Number: 1776816-321515-16

REPORT - VOLUME 4, STUDY 7

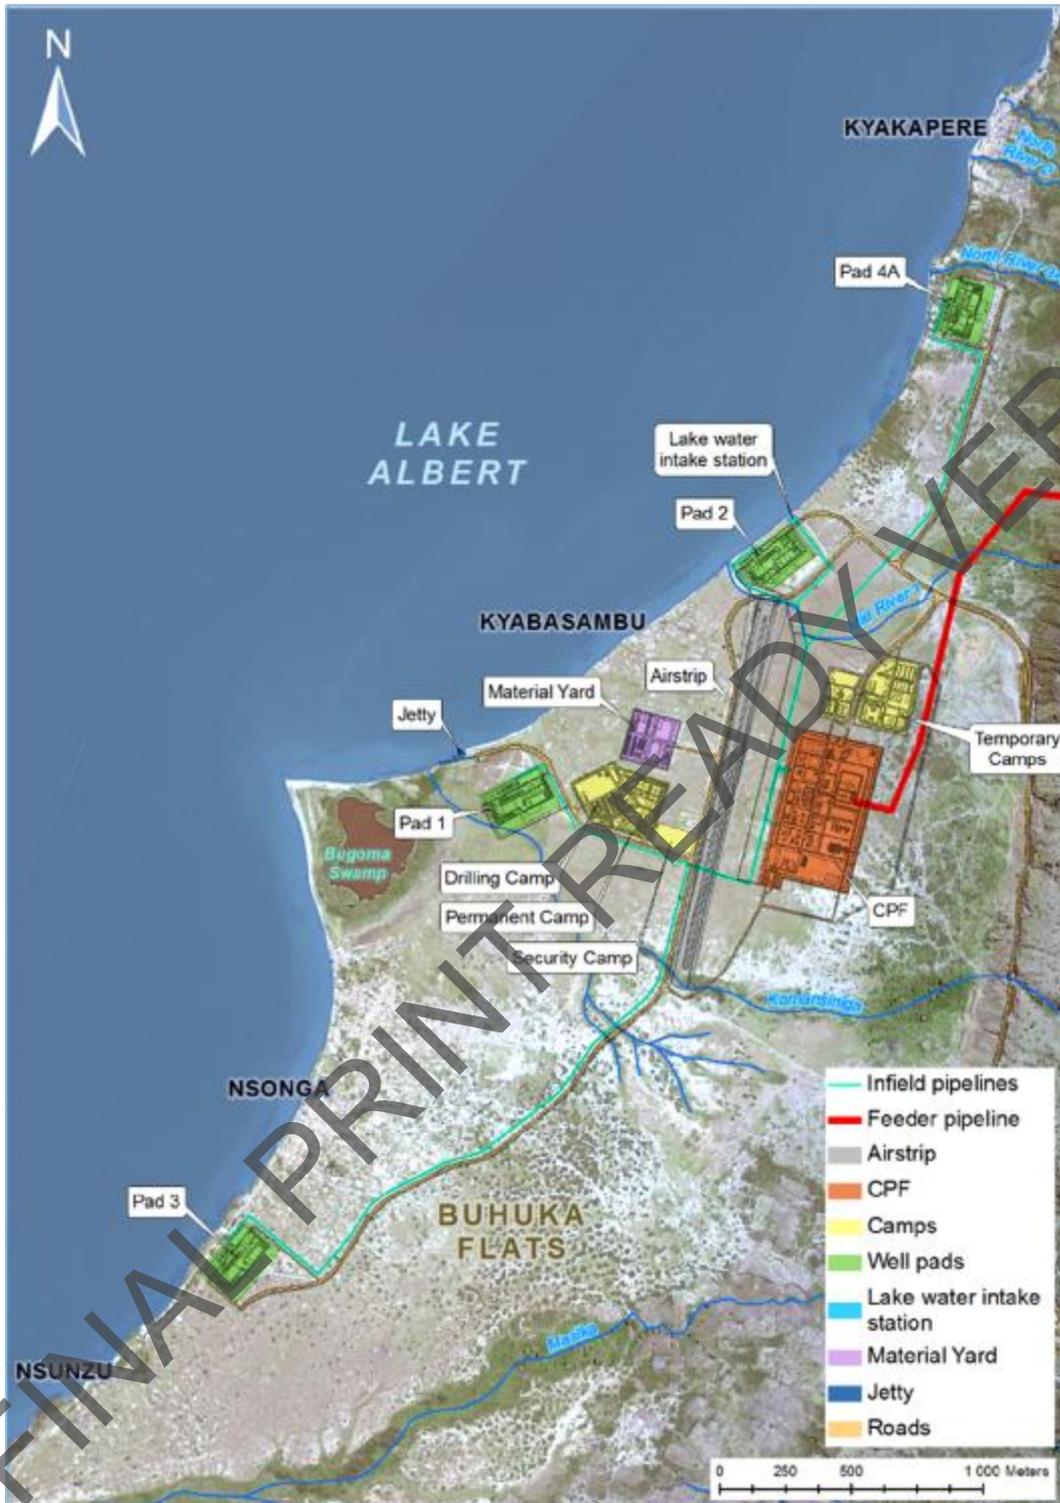
Figure 1: Project infrastructure to be developed on the Buhuka Flats

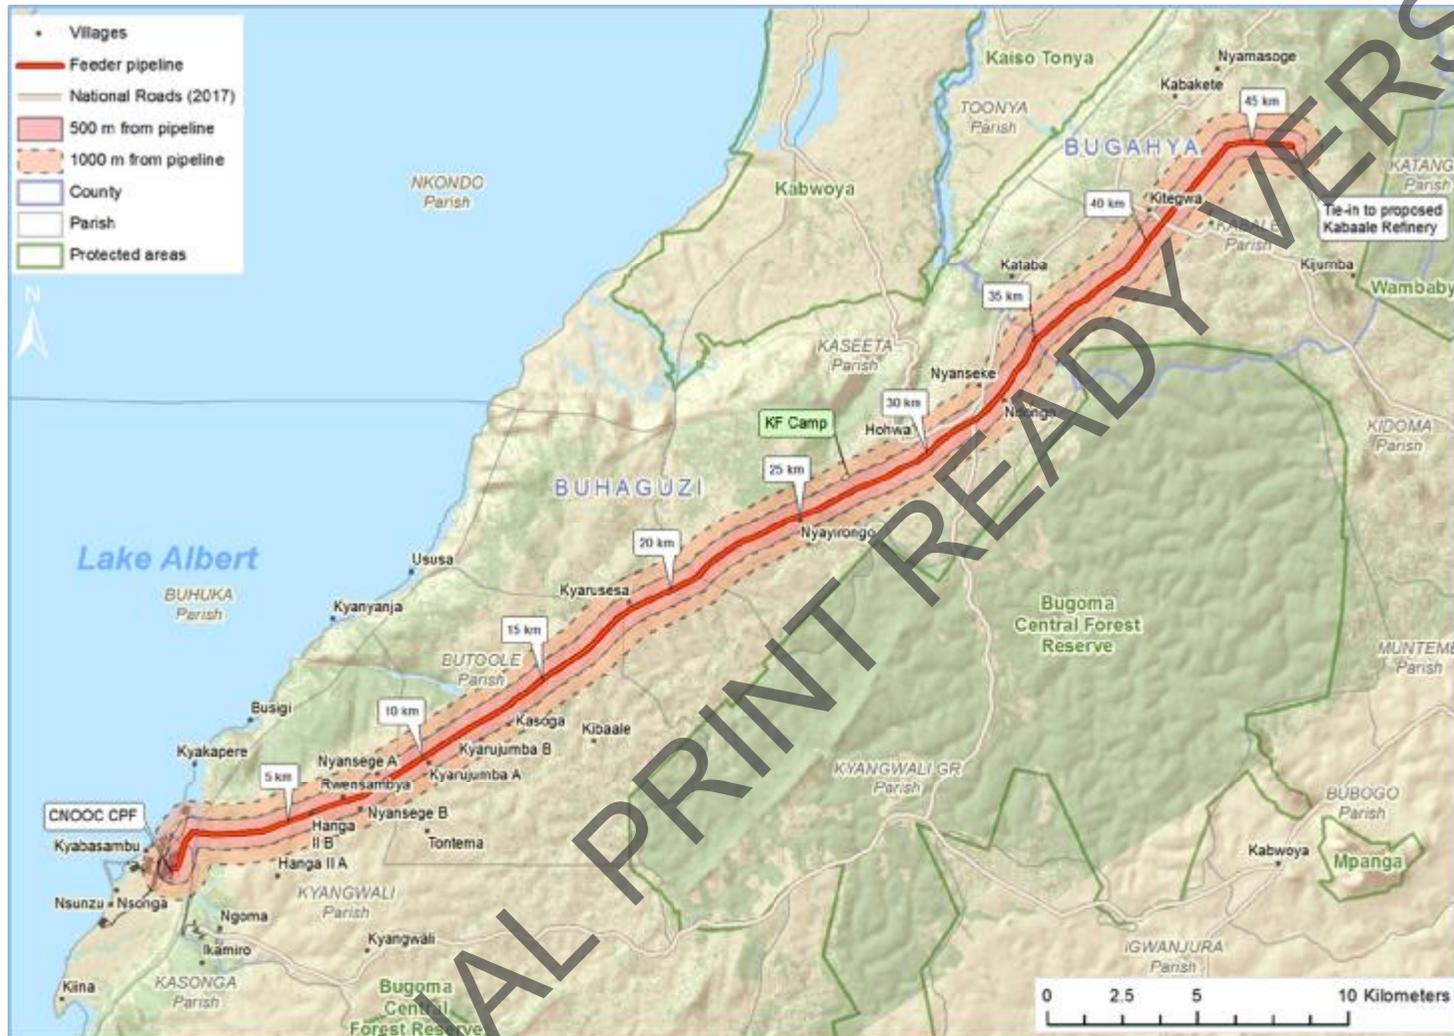
Figure 2: Project site location and feeder pipeline route

The Feeder Pipeline ends at the delivery point in Kabaale. The industrial park and the EACOP are independent projects that do not feature further in the FD-ESMP (Figure 2).

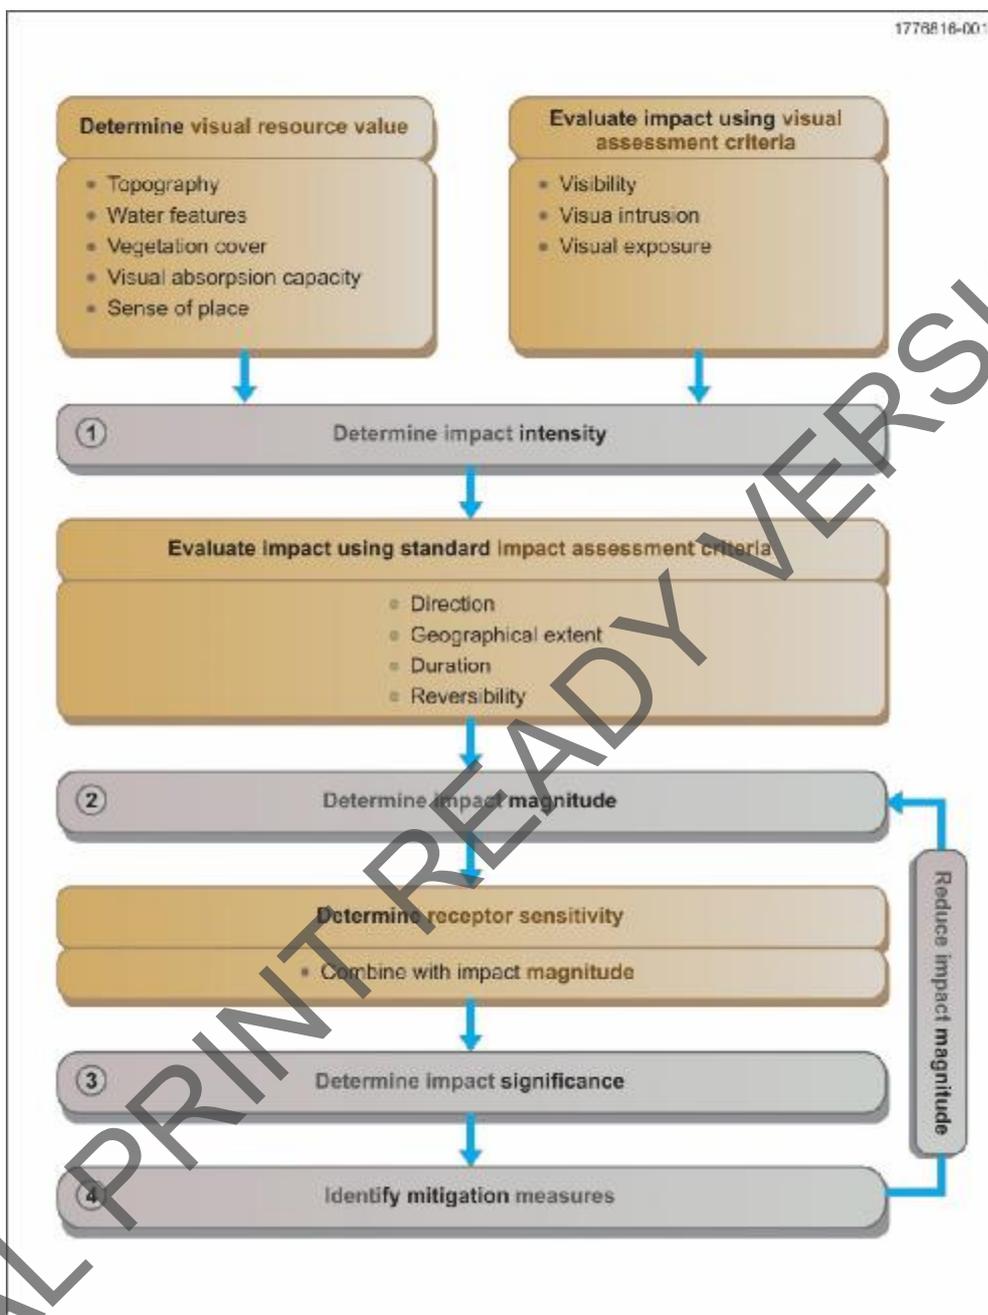
Figure 3: Visual impact assessment methodology

- i **Step three:** determining the perceived significance of the visual impact, by assessing the degree of sensitivity of the receptors together with the magnitude of the impact caused; and

- i **Step four:** Identifying potential mitigation measures to reduce or the magnitude of the visual impacts, where feasible.

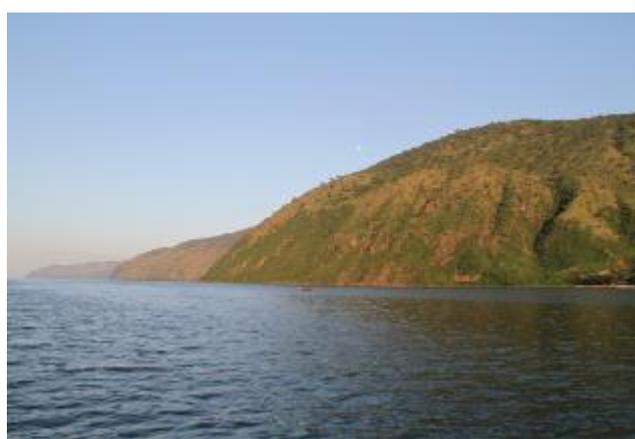
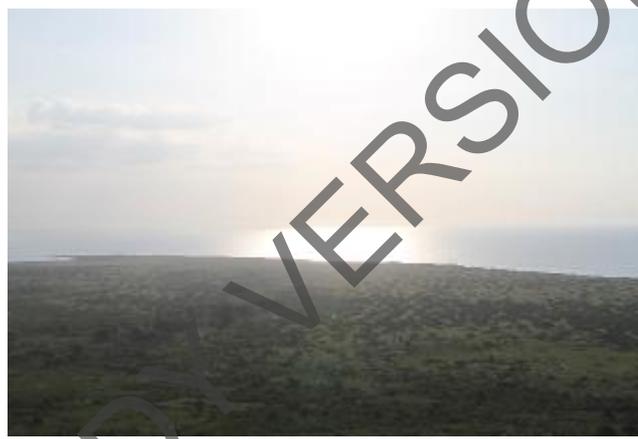
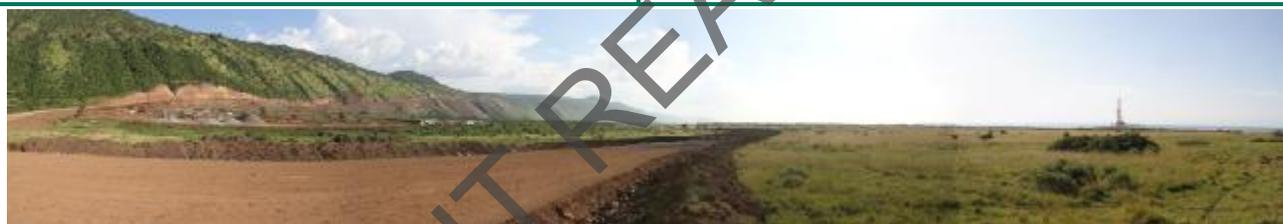
Figure 4: Topographical character of the main project study area

Vertically dominant escarpment cliffs and hills encircling Lake Albert

Horizontally dominant peninsula on which the main project site is located

The strong juxtaposition between the linear escarpment mountains and flat peninsula forms the most prominent visual attribute of the study area

These unique attributes together form one inseparable visual context, with the result that altering either landscape attribute fundamentally impacts on the visual landscape as a whole. This effect is illustrated by the third photograph in Figure 4 below, which shows the profound impact of the access road excavations and single drilling rig on the visual landscape as a whole.

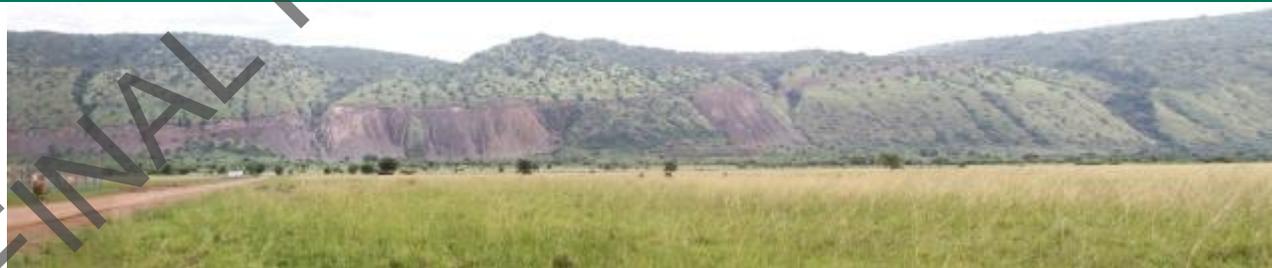
Figure 6: Vegetation cover attributes of the production site study area

The loss of vegetation cover, as well as contrasting colours and textures of the access road excavations along the escarpment is visually intrusive

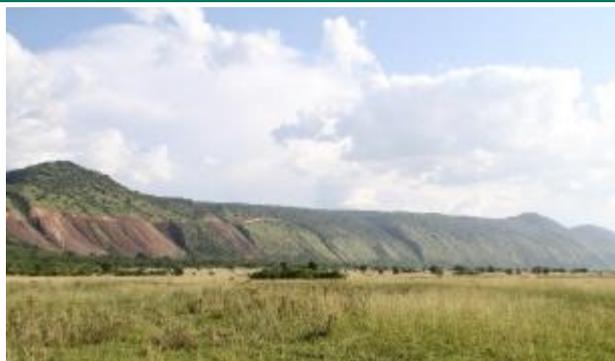
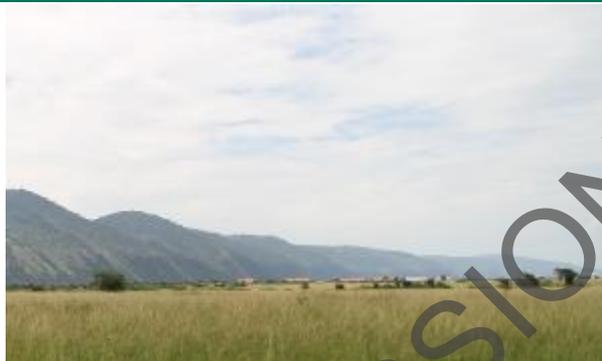
Figure 7: The study area is characterised by low levels of visual absorption capacity

The study area is mostly characterised by long range views, and a relatively narrow range of natural colours. Expansive landscape alterations (left) or the inclusion of more brightly coloured objects such as building roofs are therefore very visible, even over considerable distances (right)

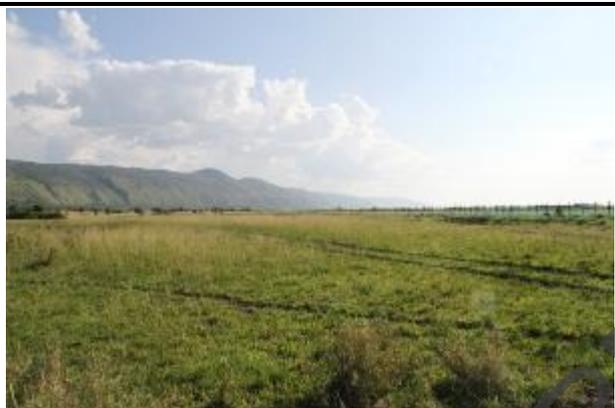
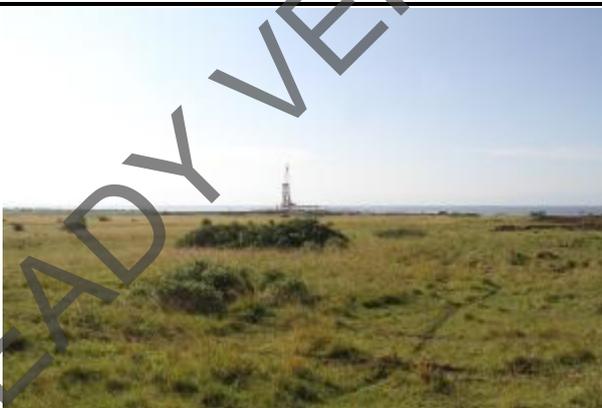
The low horizon line of much of the study area (left) means that any vertically prominent structures that protrude above it such as the existing drill rig, are highly prominent (right)

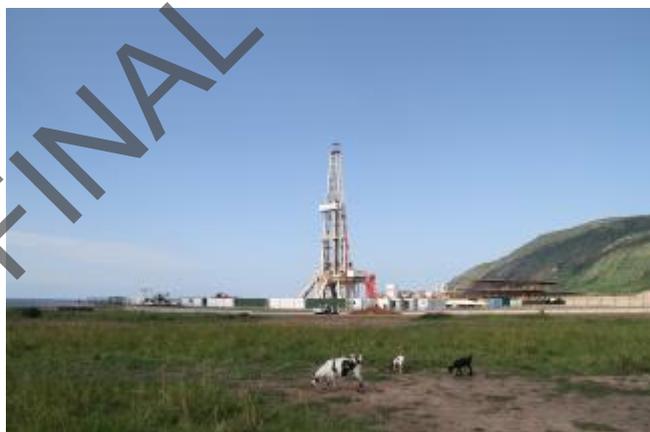
The existing well pad 2 rig forms a prominent vertical landmark that contrasts with the study area sense of place

By contrast, the tall well pad 2 pilot drill rig forms a prominent vertical and visually contrasting landmark in the landscape. Other components of the pilot infrastructure are less prominent, but still form strongly linear visual pathways through the landscape, especially the airfield and access road excavations.

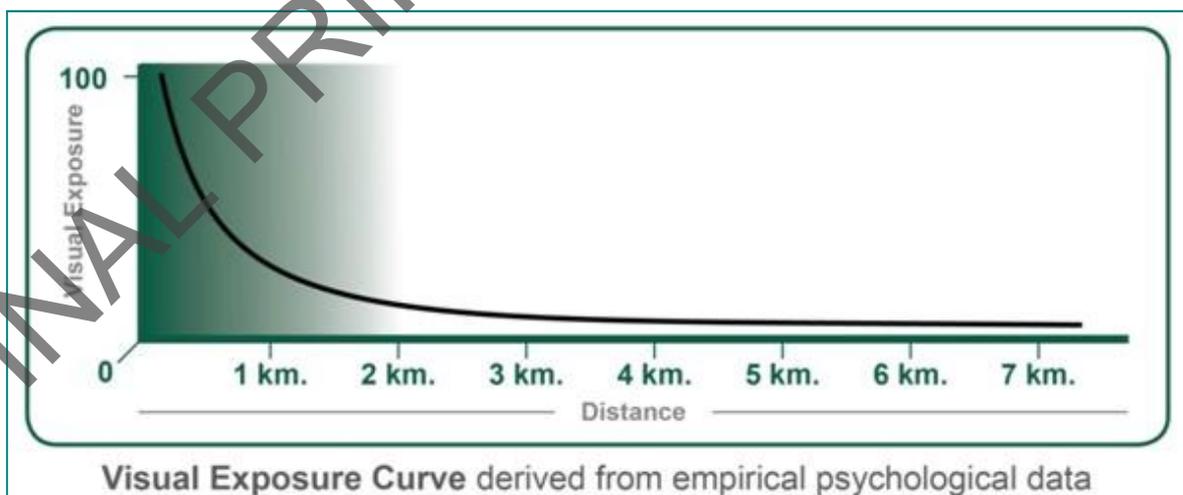
Figure 10: Visual impact vs. visual exposure distance

The visual impact of a development diminishes at an exponential rate as the distance between the observer and the object increases – refer to Figure 10. Relative humidity and fog in the area directly influence the effect. Increased humidity causes the air to appear greyer, diminishing detail. Thus, the impact at 1 000 m would be 25% of the impact as viewed from 500 m. At 2 000 m it would be 10% of the impact at 500 m. The inverse relationship of distance and visual impact is well recognised in visual analysis literature (Hull, R.B and Bishop, I.E, 1998) (Hull, R.B and Bishop, I.E, 1998) and was used as important criteria for this study.

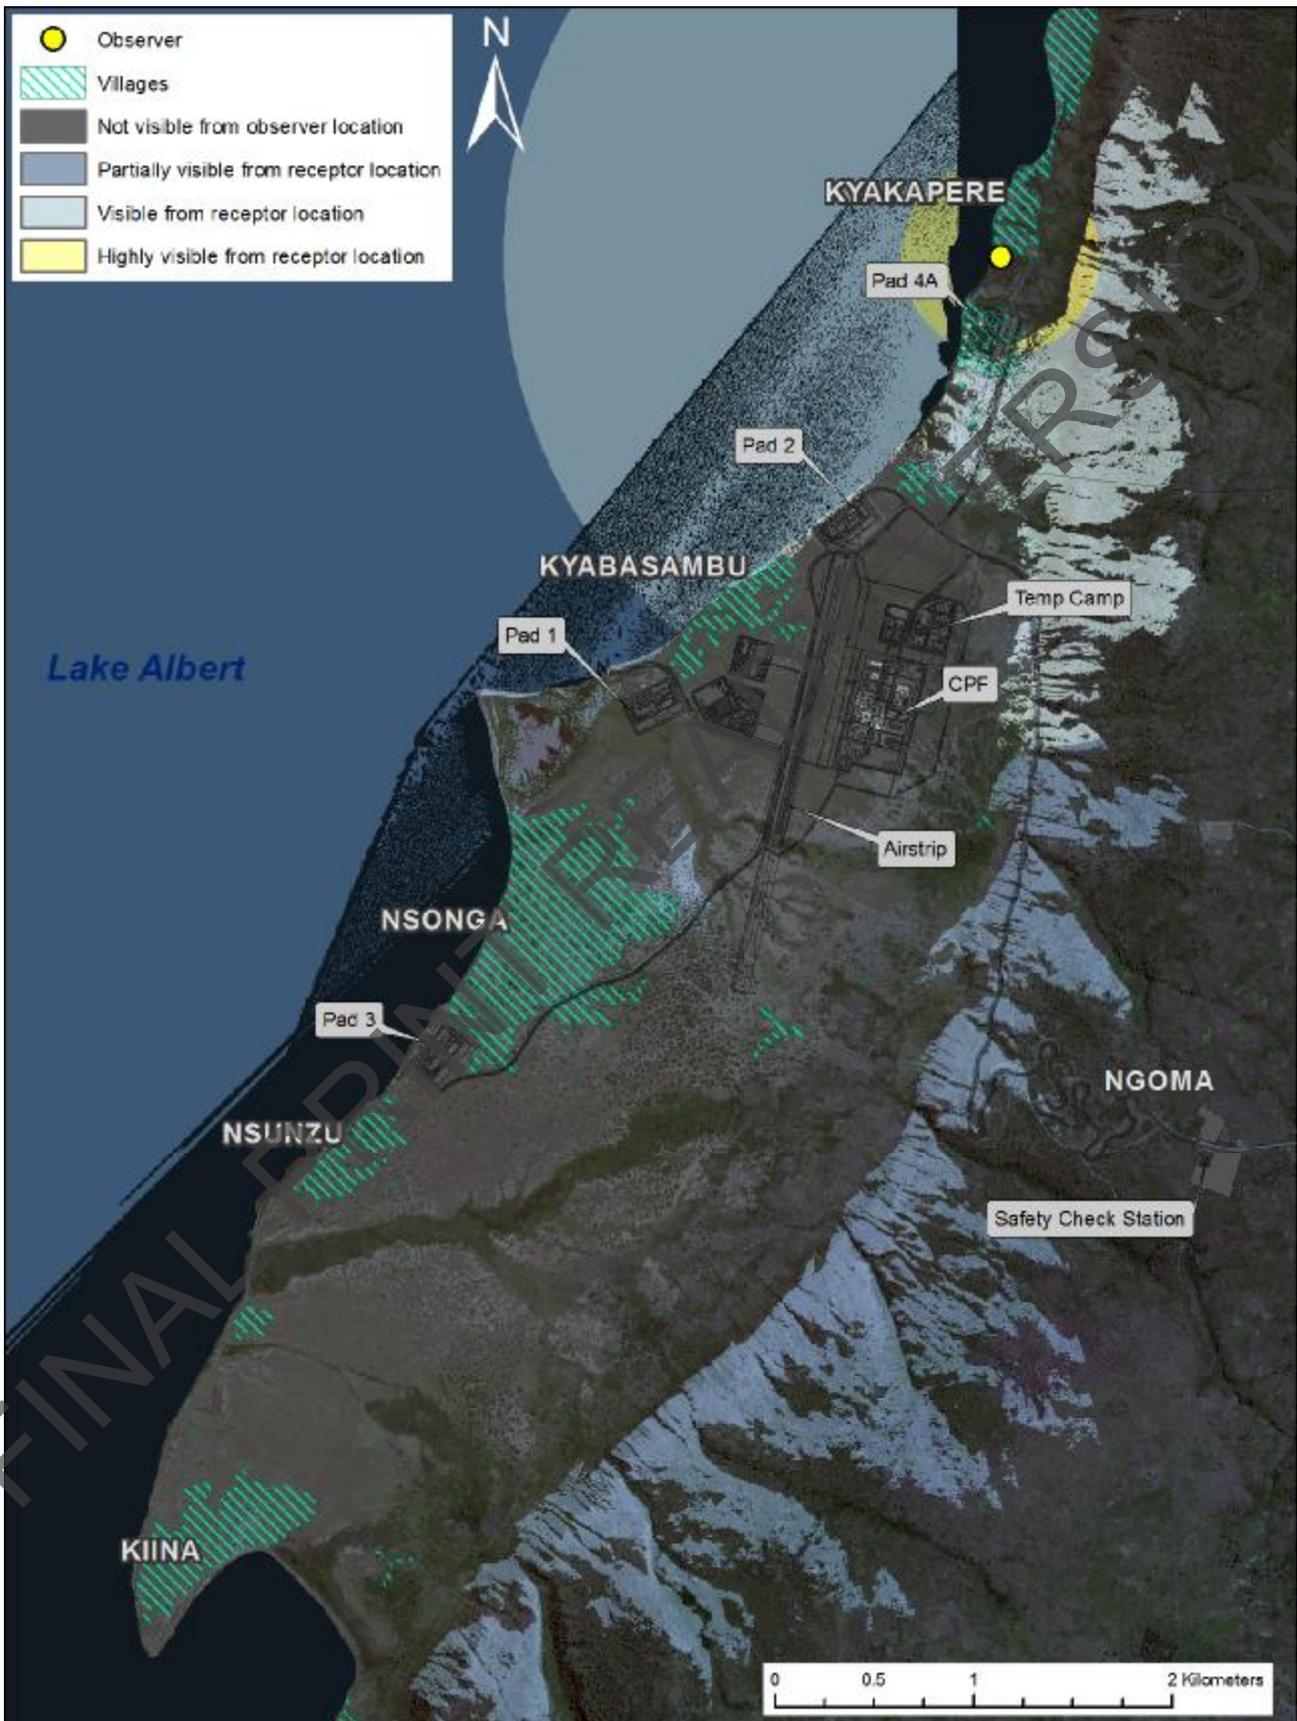
Figure 11: Visibility of project infrastructure from Kyakapere village (receptor-based viewshed)

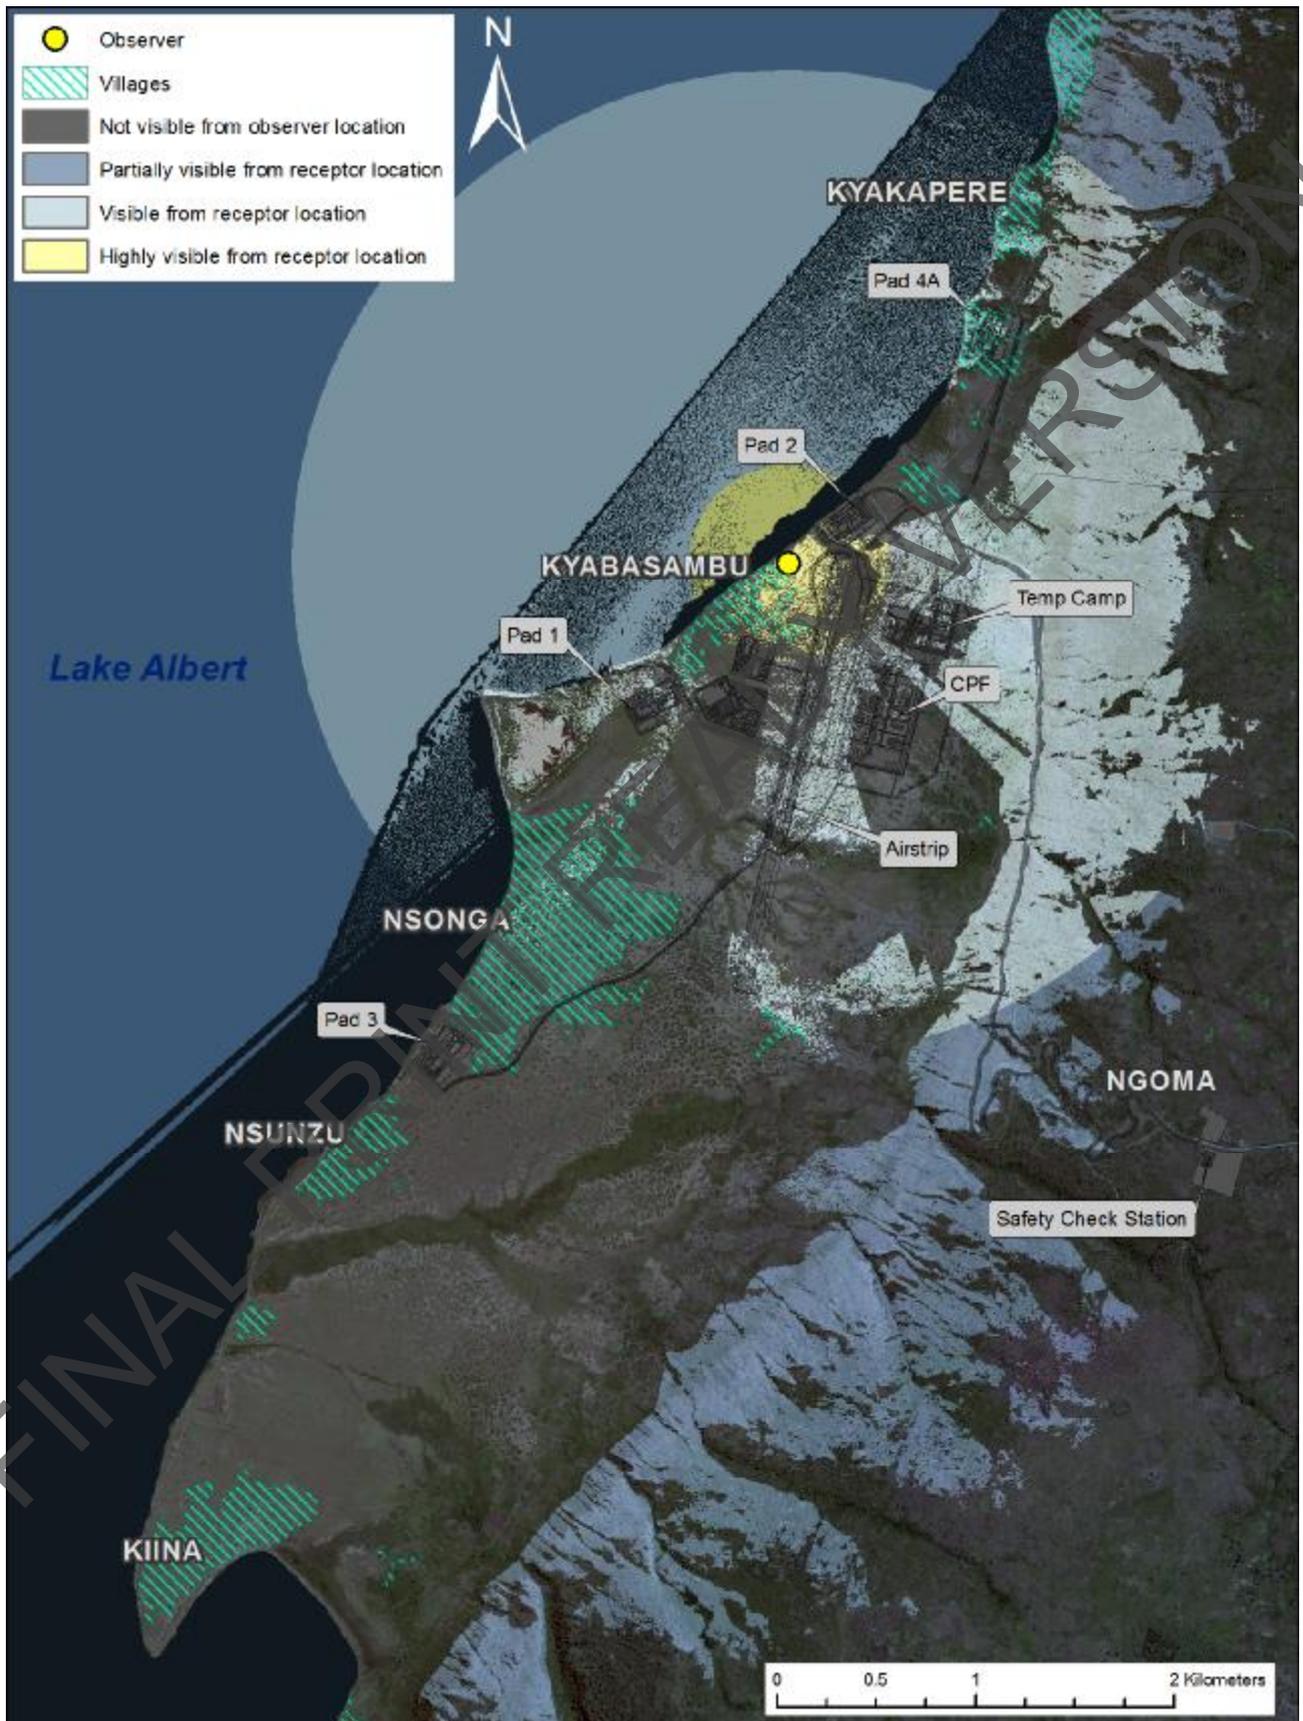
Figure 12: Visibility of project infrastructure from Kyabasambu village (receptor-based viewshed)

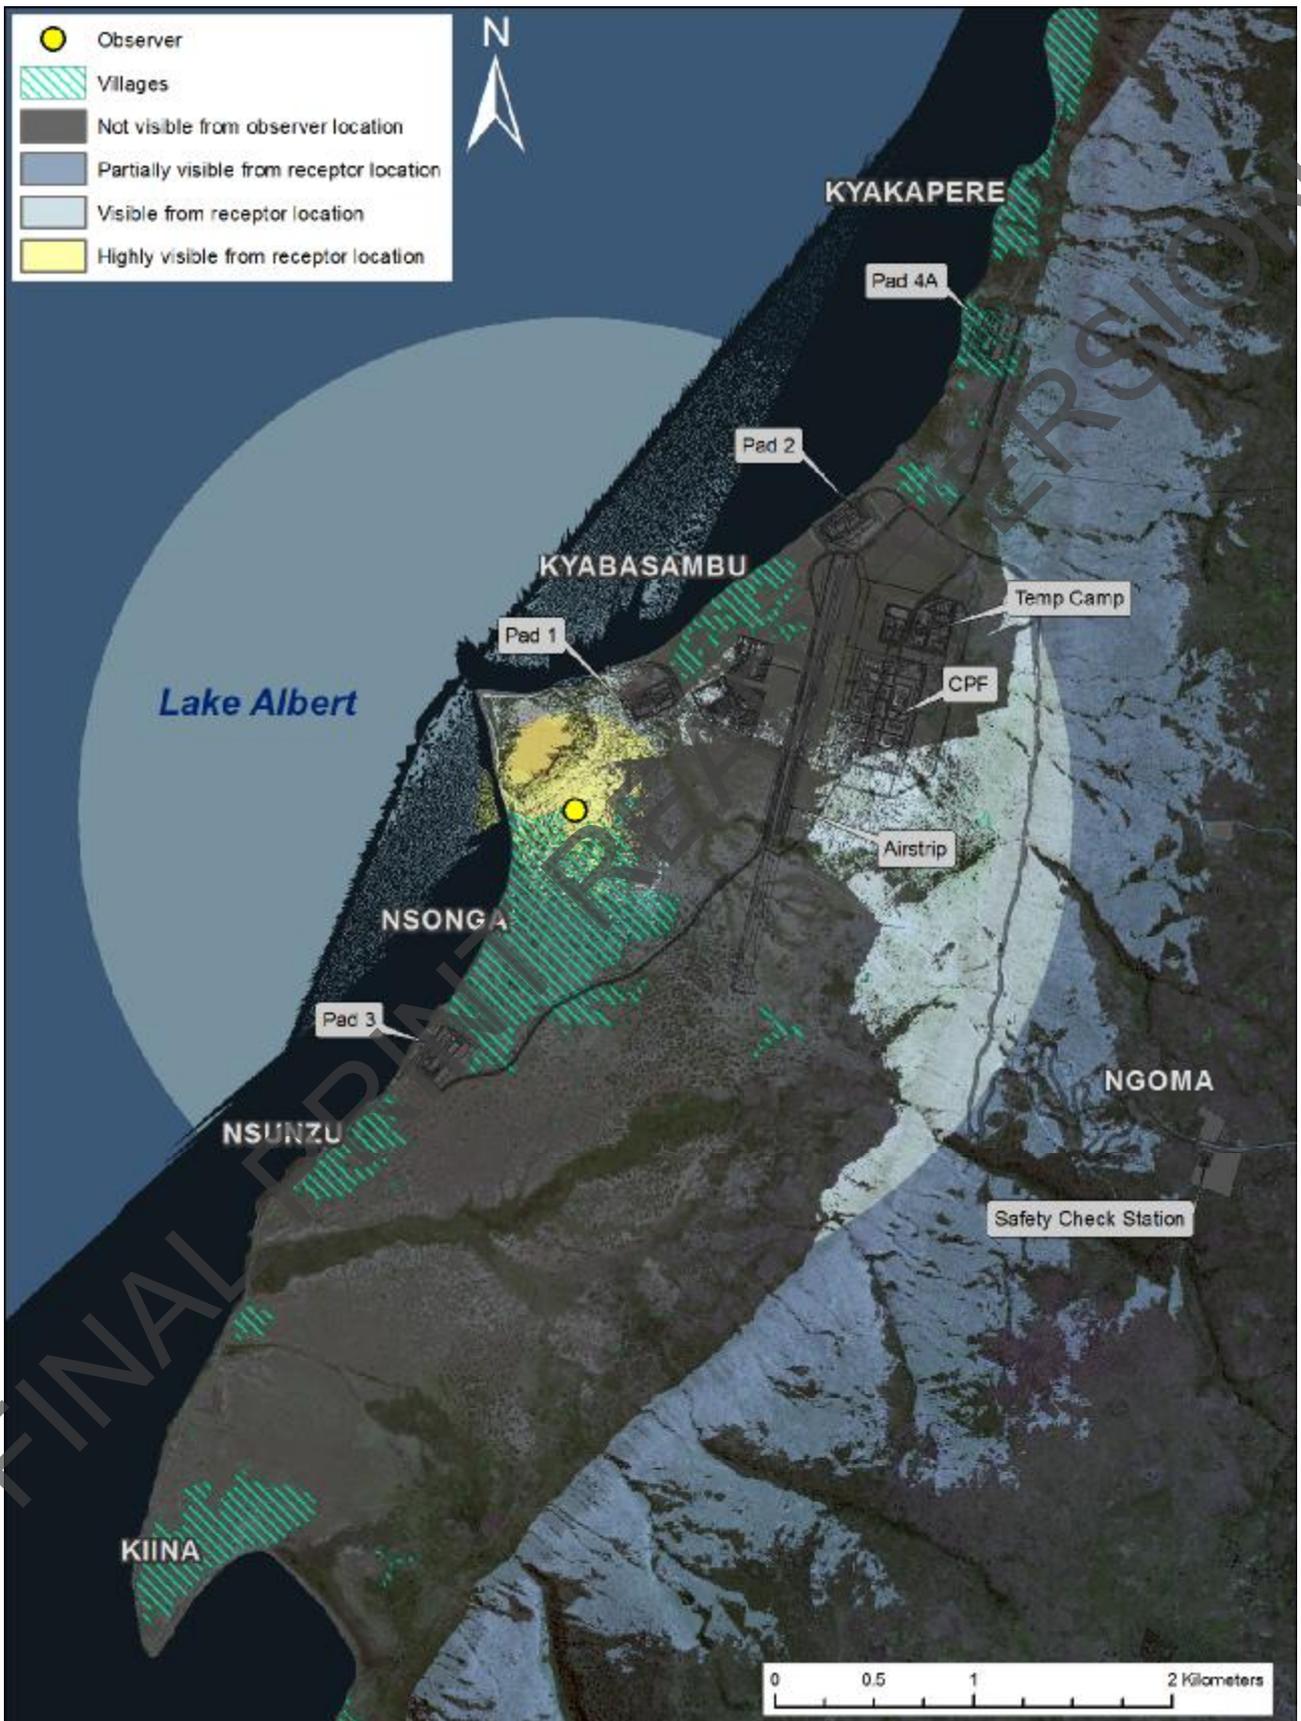
Figure 13: Visibility of project infrastructure from Nsonga village north (receptor-based viewshed)

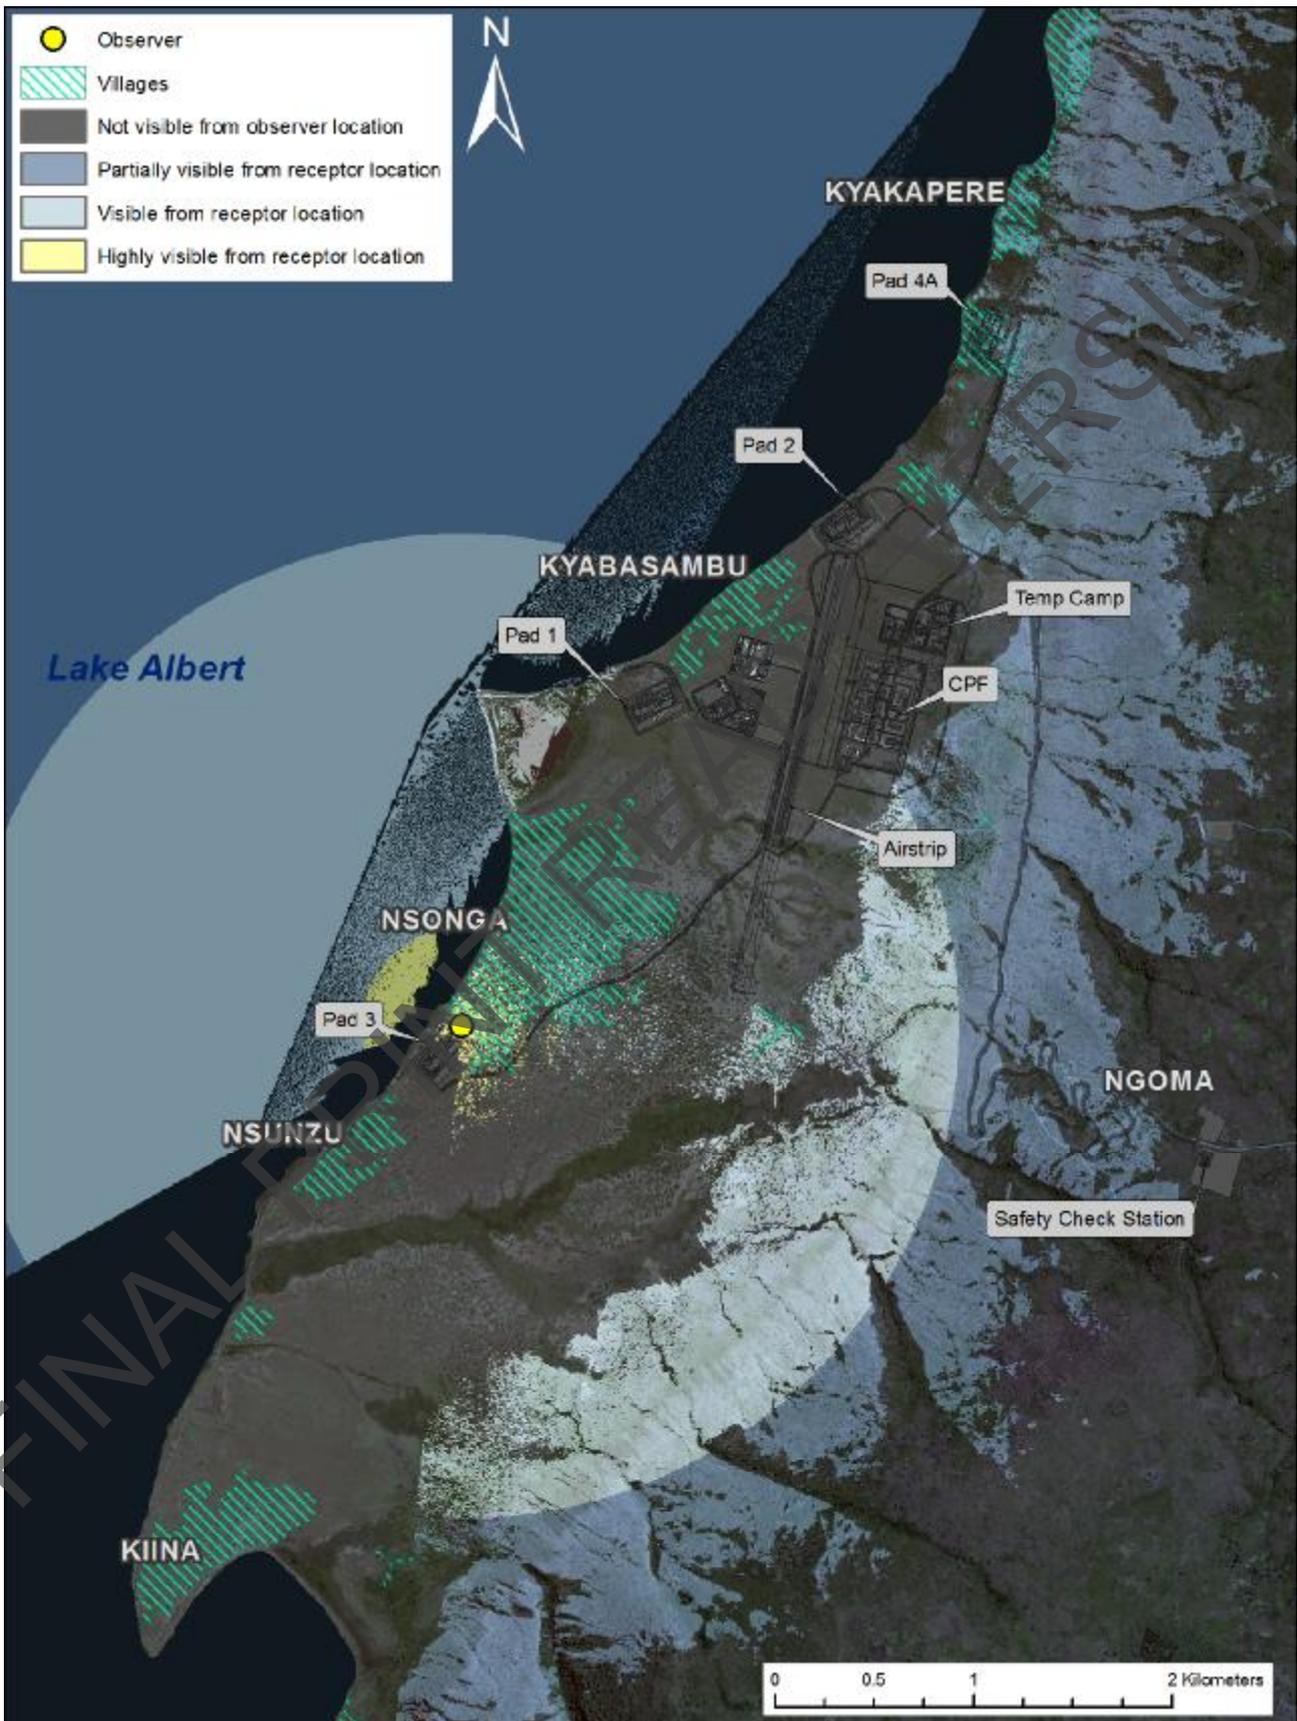
Figure 14: Visibility of project infrastructure from Nsonga village south (receptor-based viewshed)

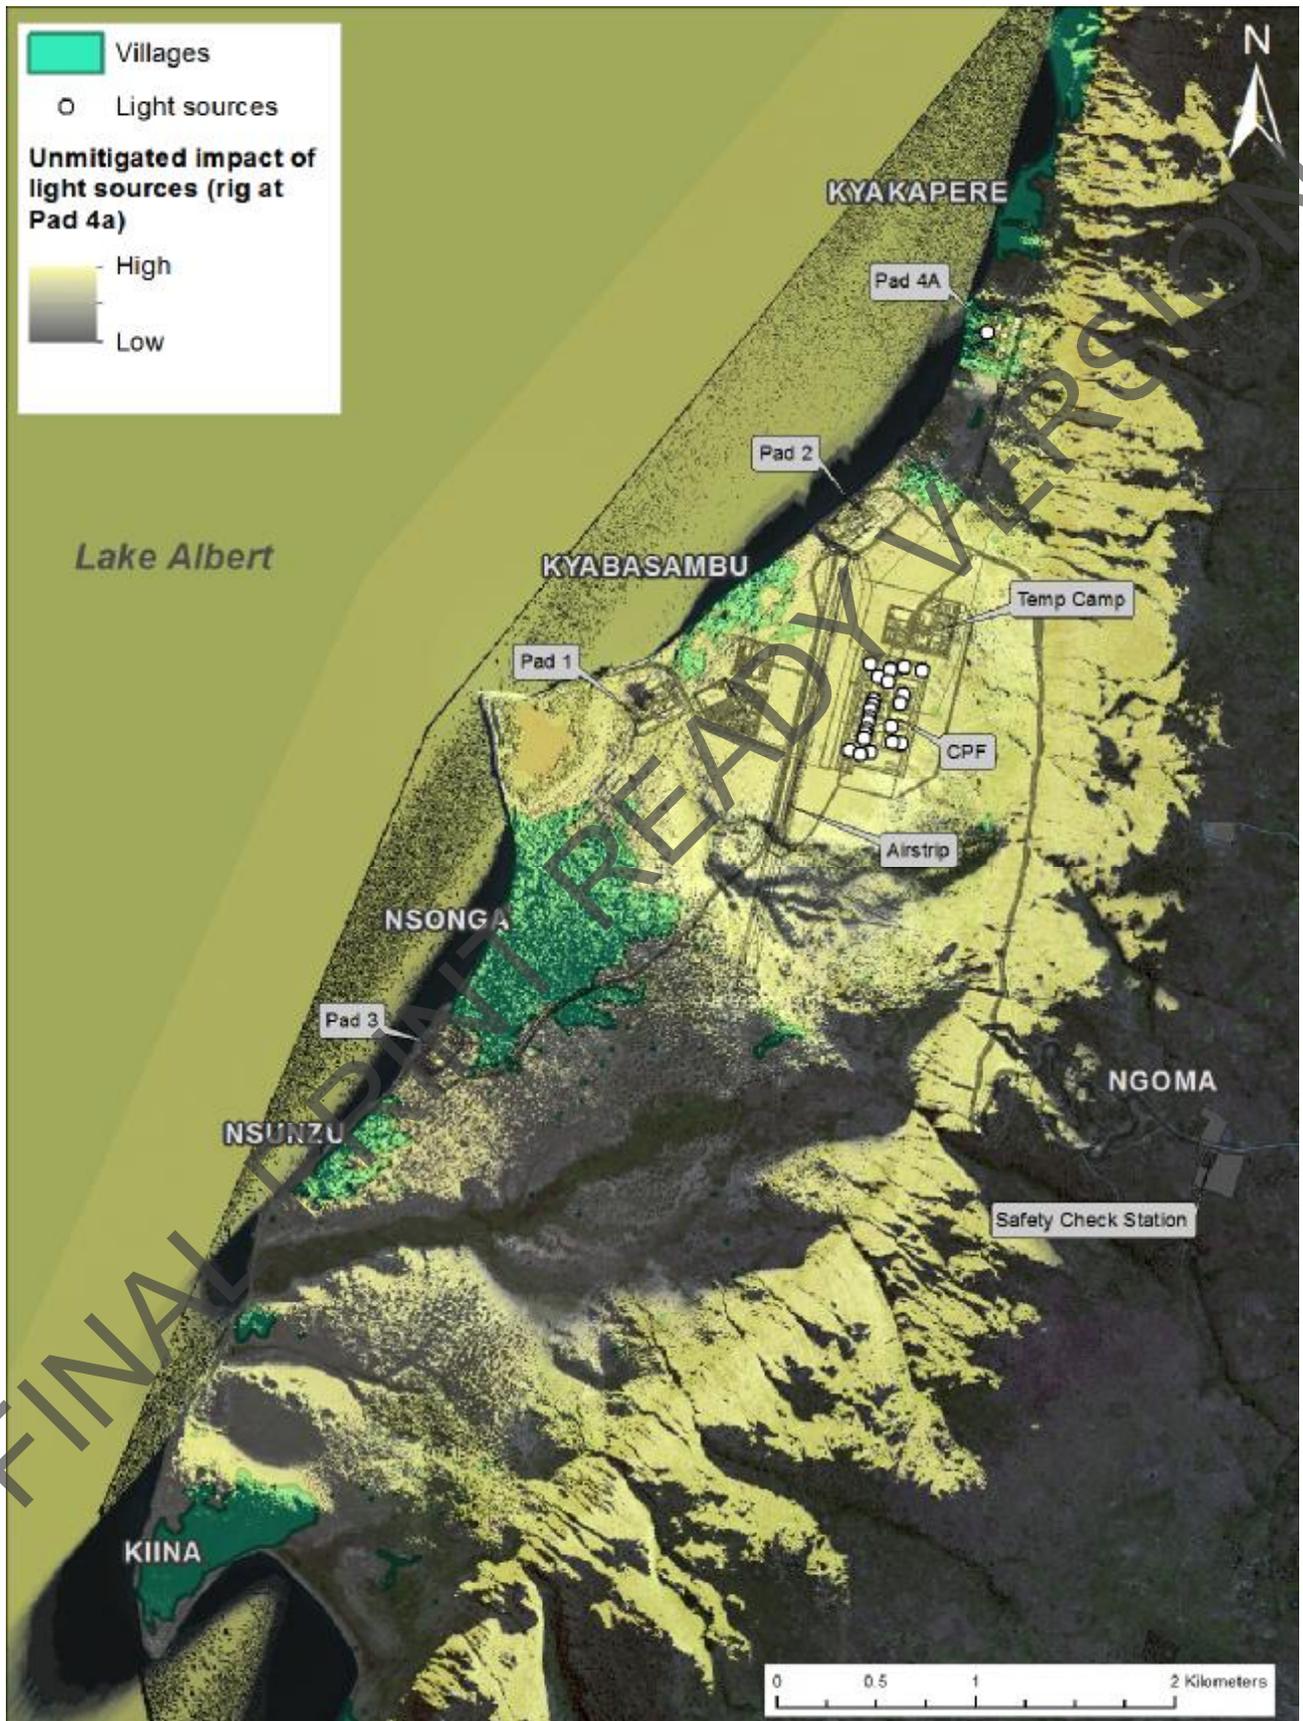
Figure 15: Night-time illumination within study area for CPF and drill rig at well pad 4 (impactor-based viewshed)

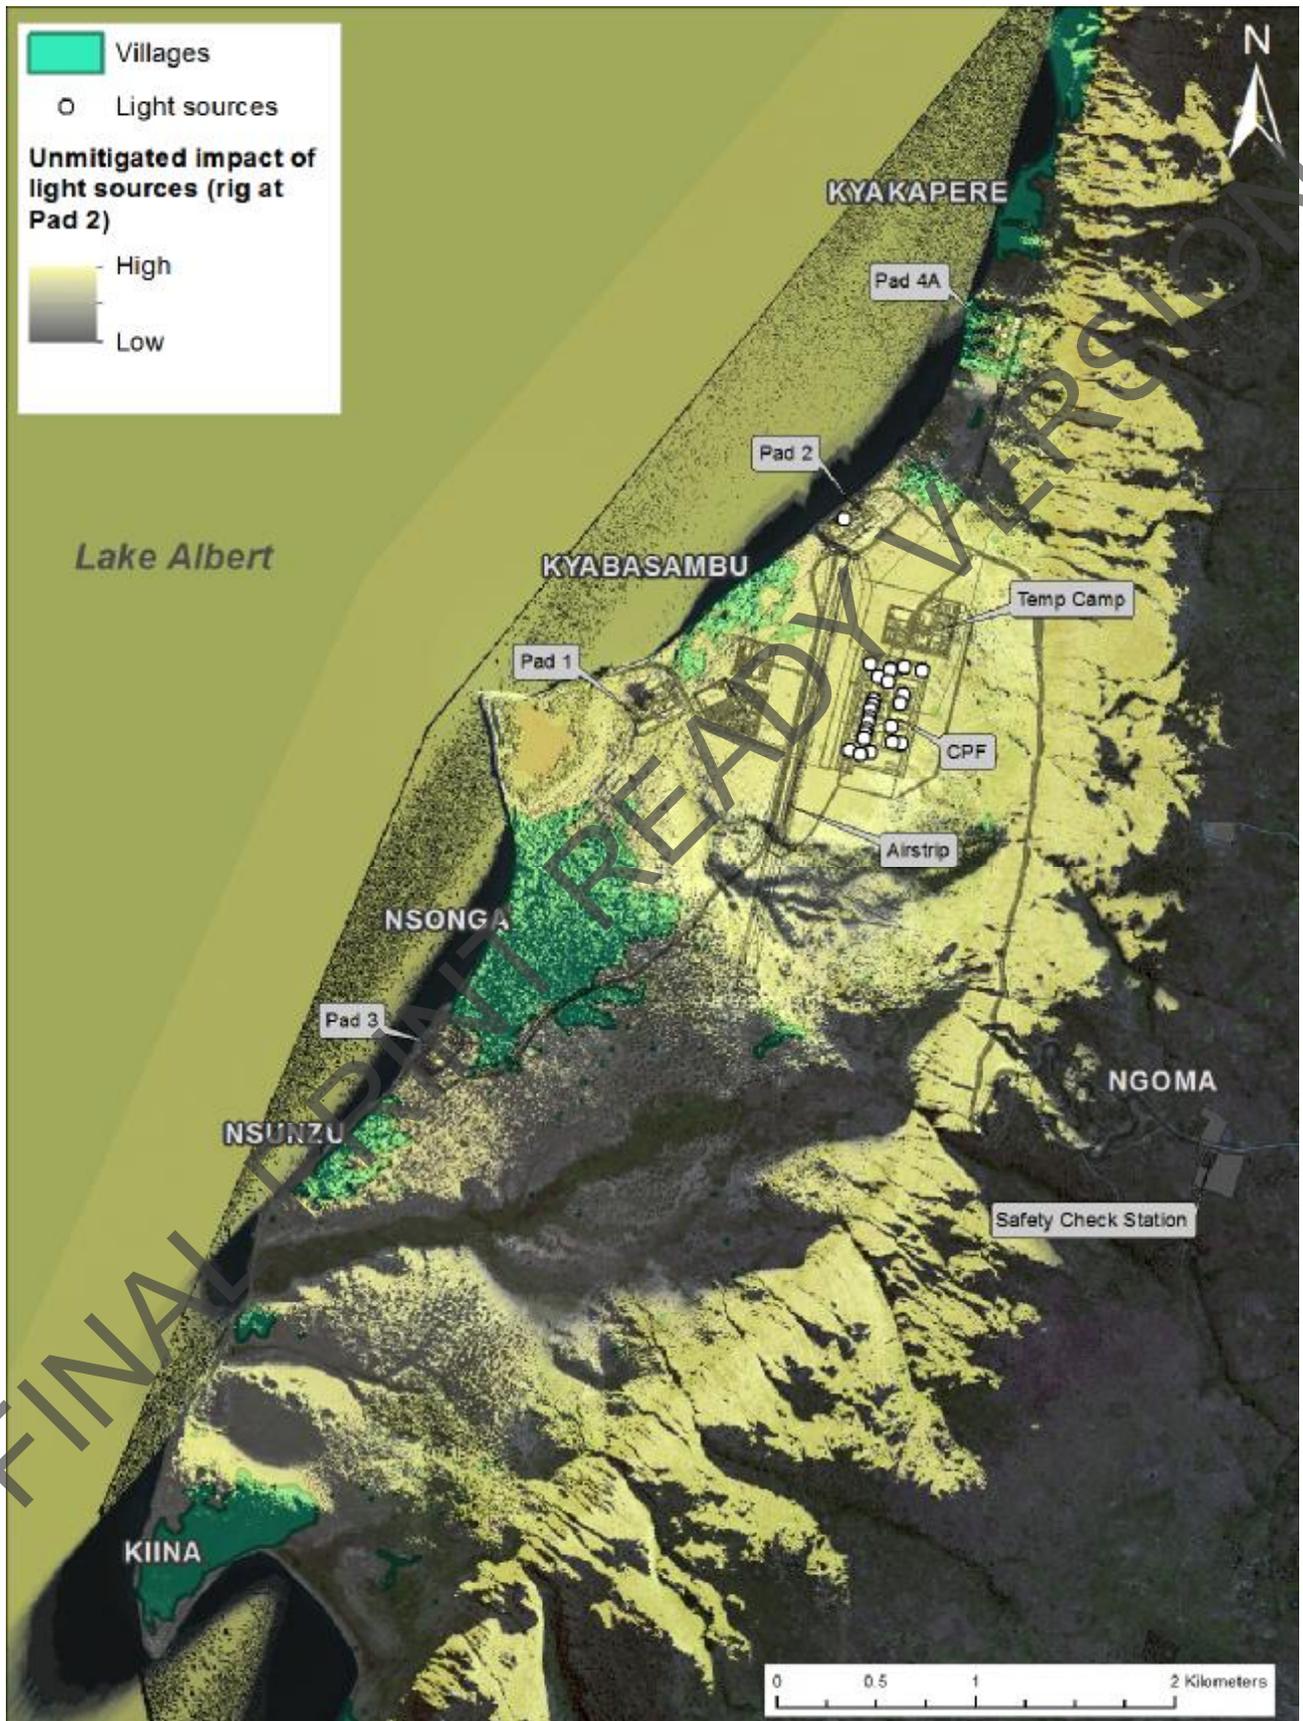
Figure 16: Night-time illumination within study area for CPF and drill rig at well pad 2 (impactor-based viewshed)
