CNOOC UGANDA LIMITED

Visual Impact Assessment Report for the Proposed Kingfisher Development

Report Number: 1776816-321515-16

REPORT - VOLUME 4, STUDY 7

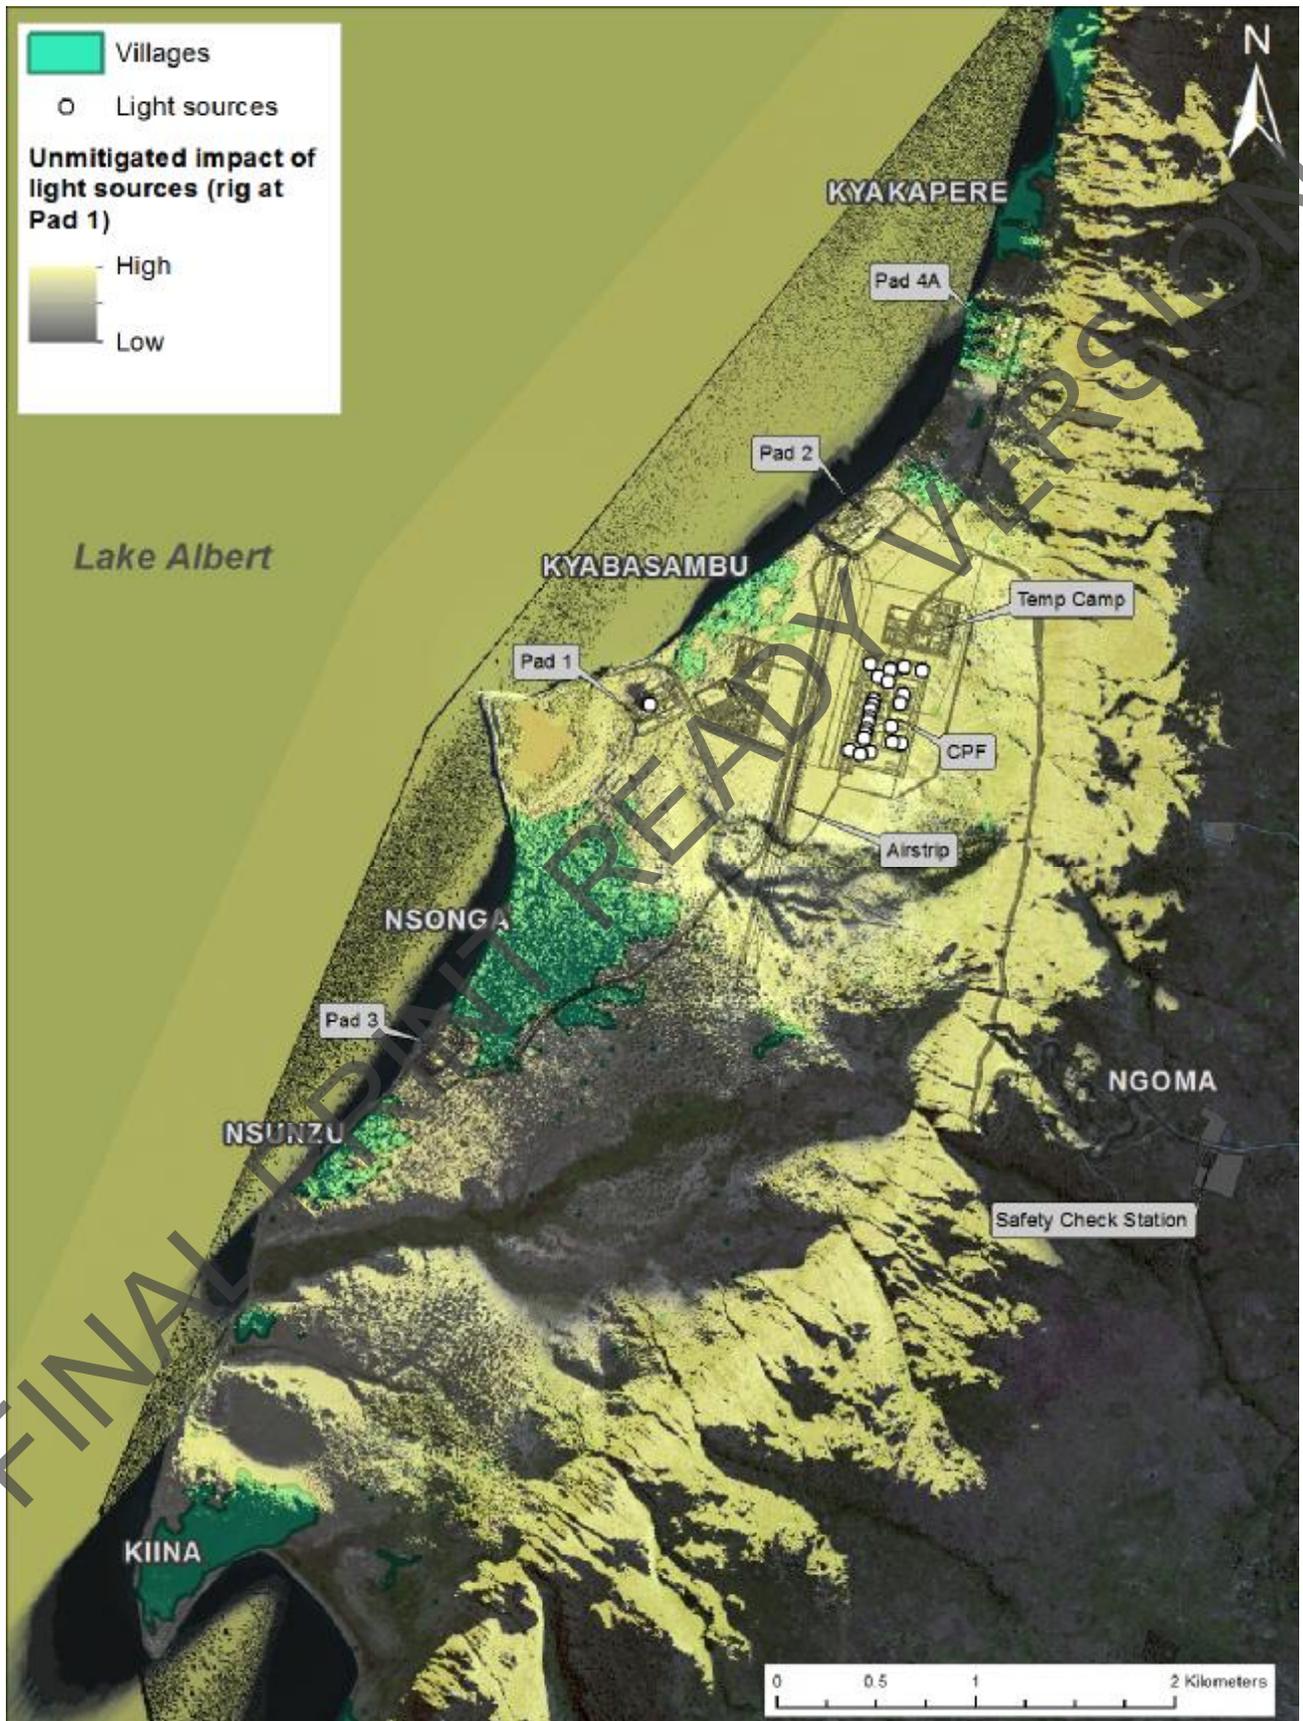
Figure 17: Night-time illumination within study area for CPF and drill rig at well pad 1 (impactor-based viewshed)

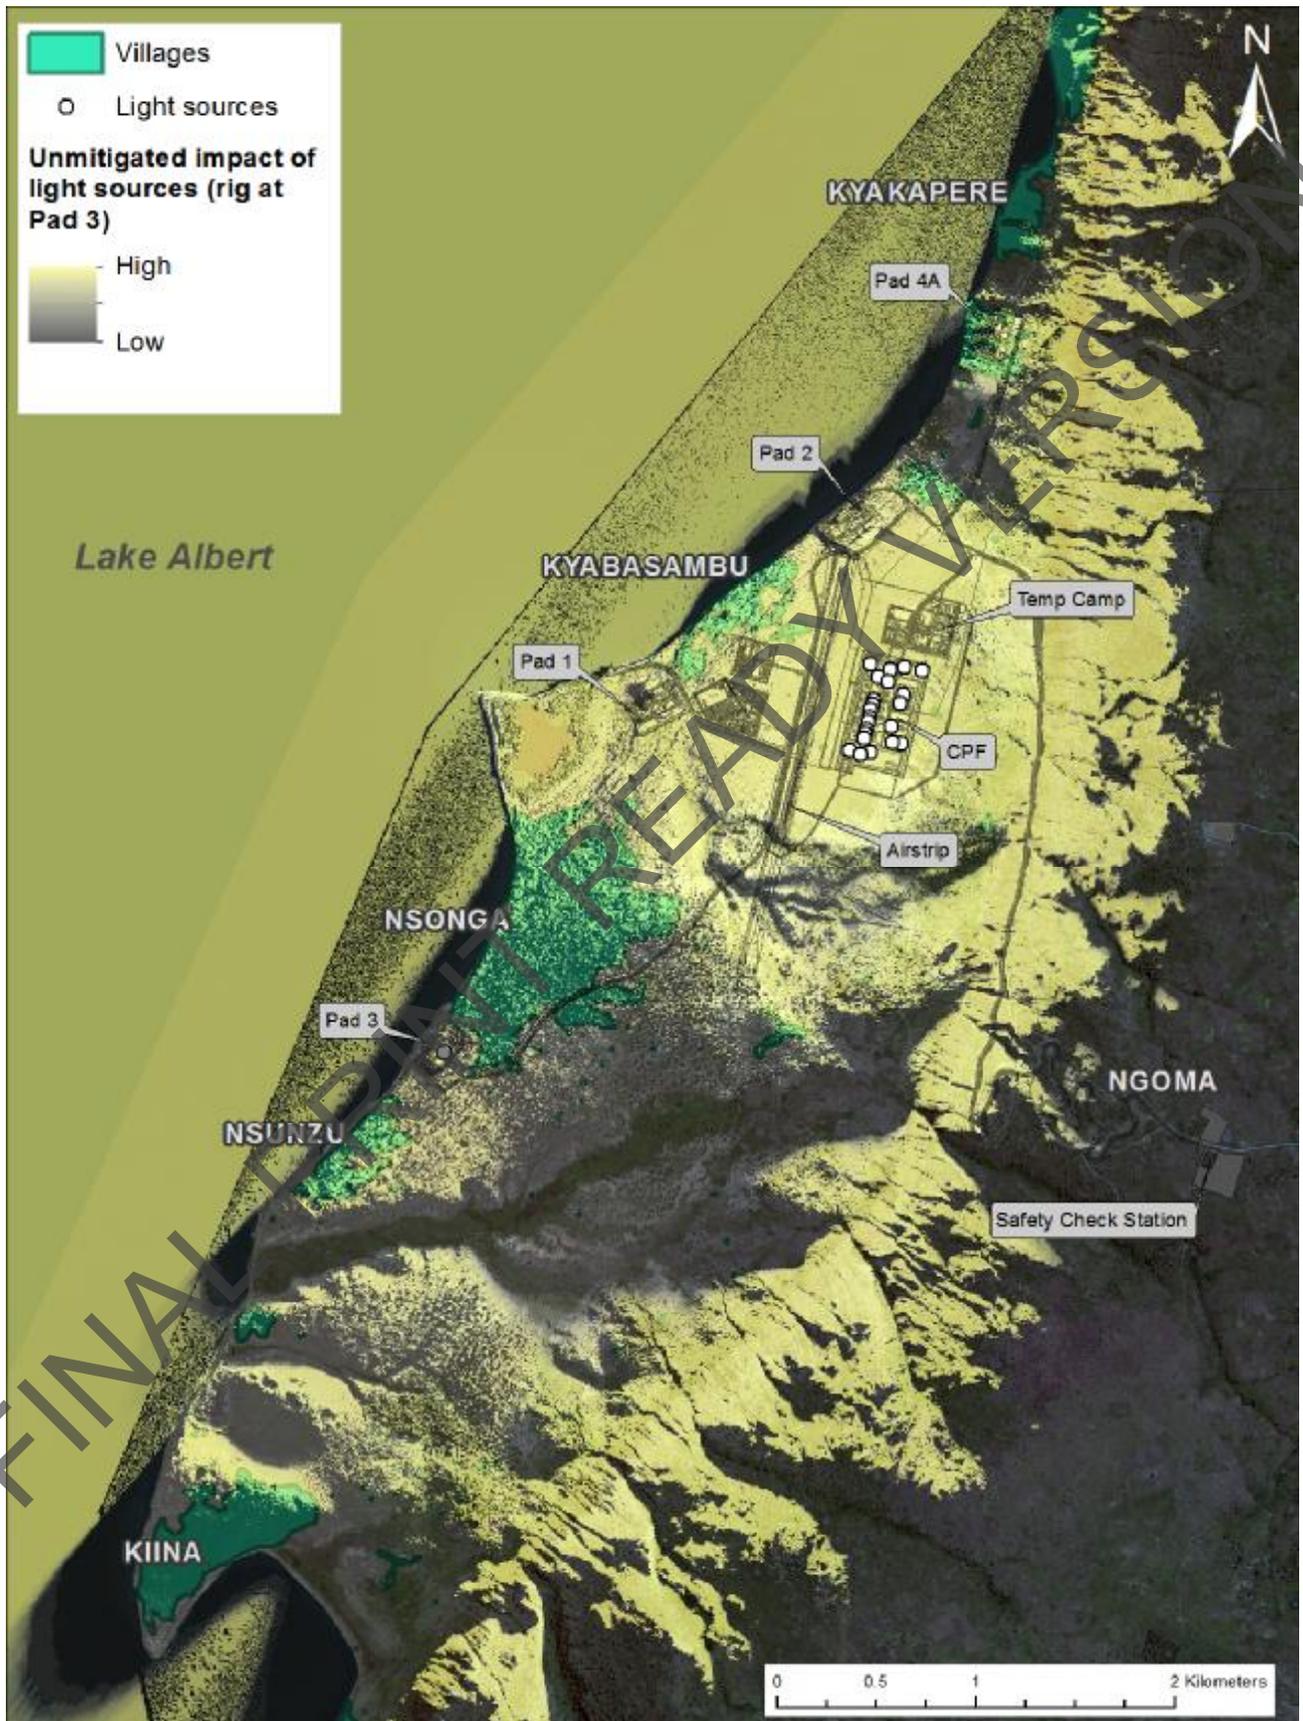
Figure 18: Night-time illumination within study area for CPF and drill rig at well pad 3 (impactor-based viewshed)

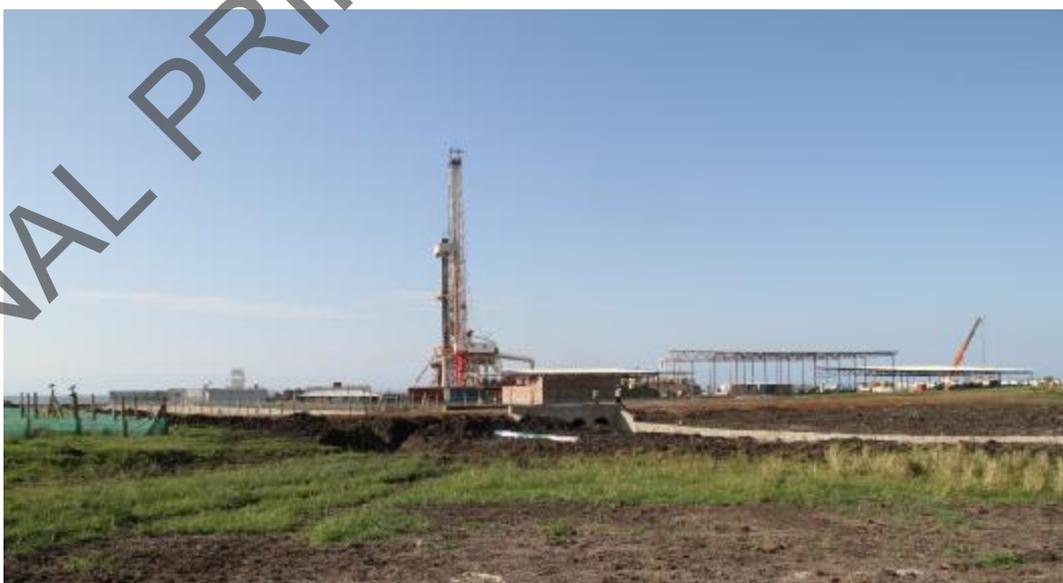
Figure 19: The well pad drill rig is the most visually intrusive element of the project

The visual intrusion caused by the project at day is mainly as a result of the bright, contrasting primary colours and strongly geometric shapes of the production infrastructure, as well as vertical height in the case of the drill rig Figure 19. The level of visual intrusion is further emphasised when this infrastructure is viewed against the sky as backdrop, which further emphasises its manmade and artificial appearance.

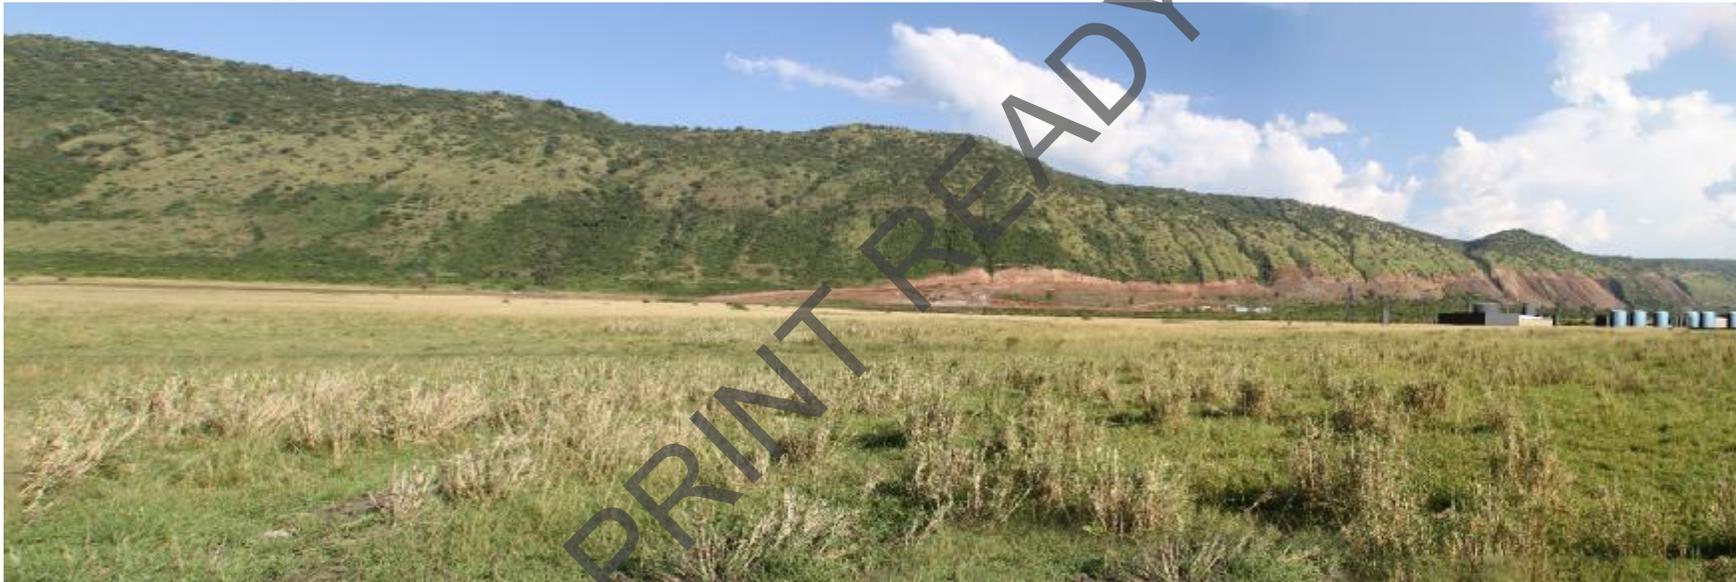
Figure 20: Daytime view of the CPF site from the northwest, after construction of the project infrastructure

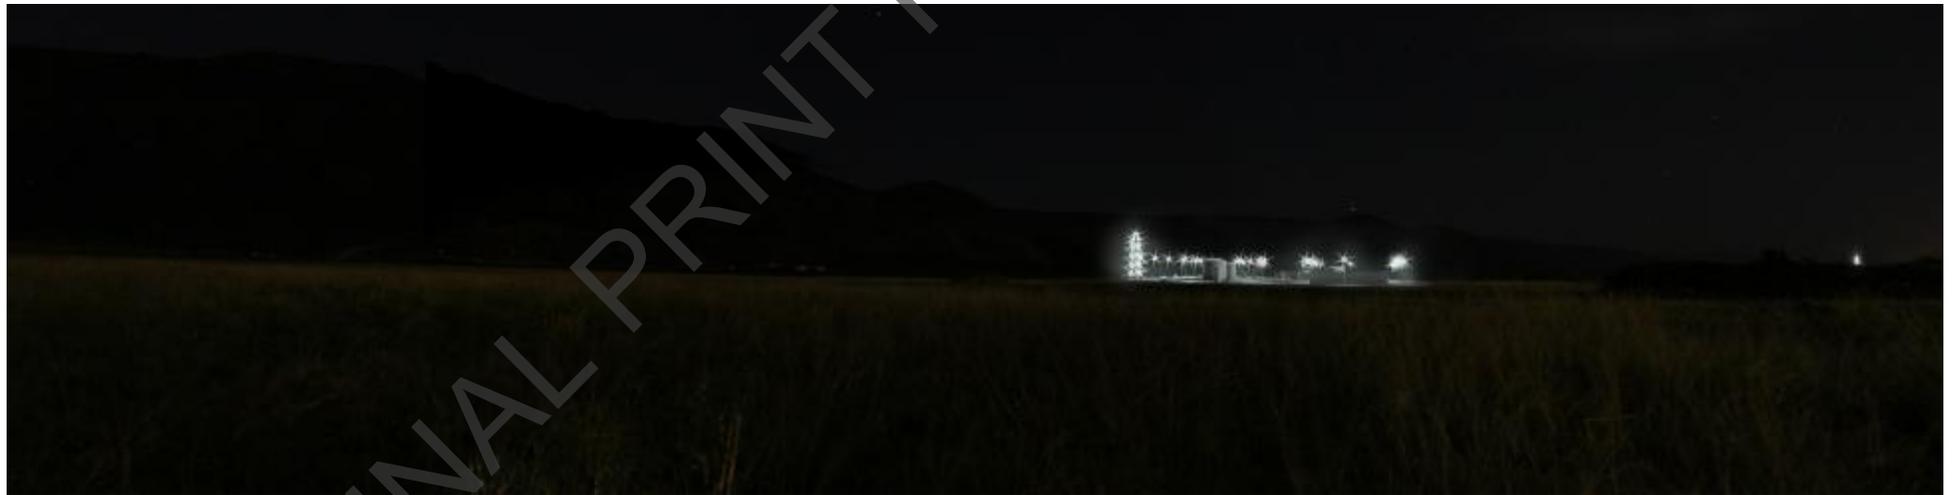
Figure 21: Night-time view of the CPF site from the northwest, before (top) and after (bottom) construction of the project infrastructure

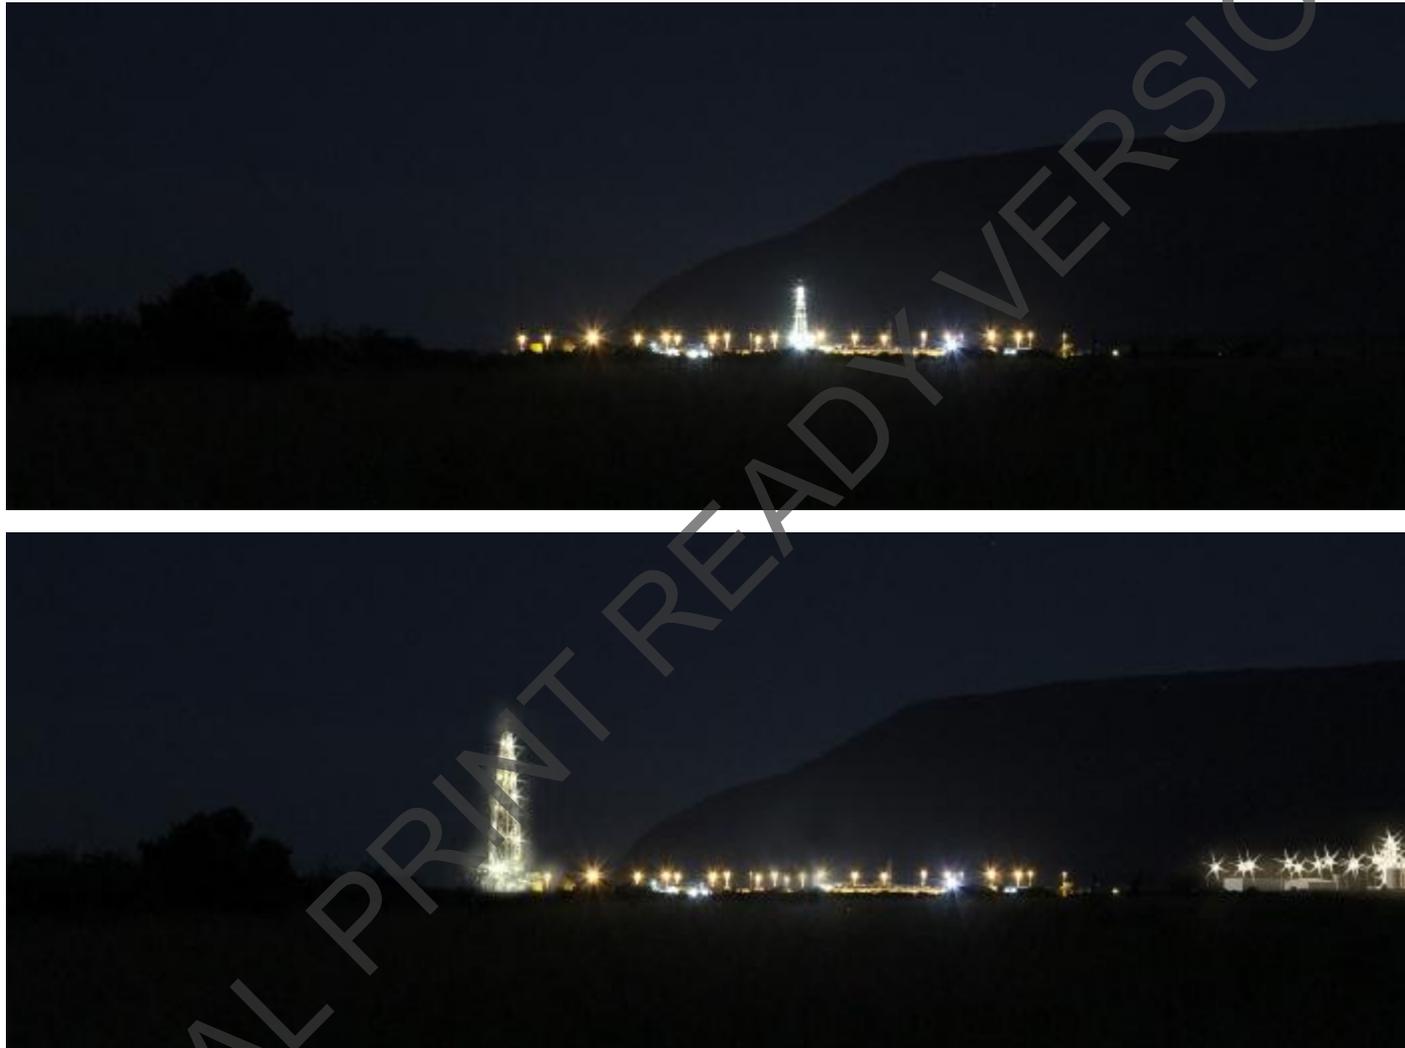
Figure 22: Night-time view of the permanent camp, CPF site and well pads 1 and 2 positions, before (top) and after (bottom) construction of the project infrastructure

Note: in the “after” (bottom) image, the drill rig has been moved from well pad 2 further north to well pad 1, located approximately 500 m from the viewer

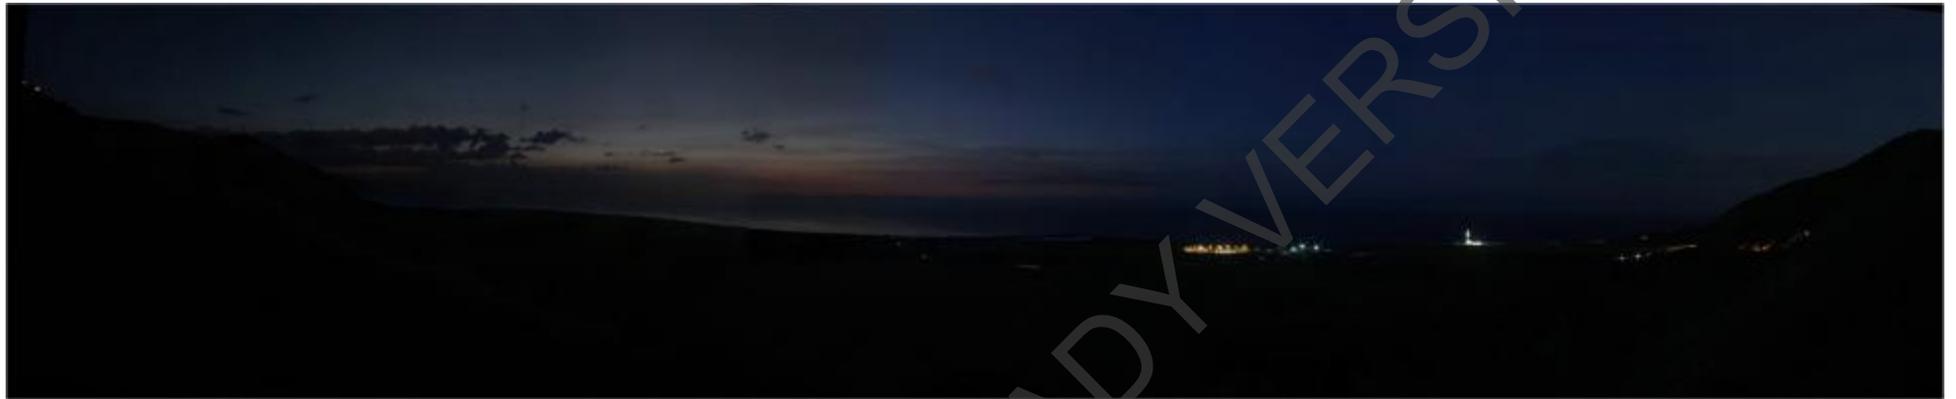
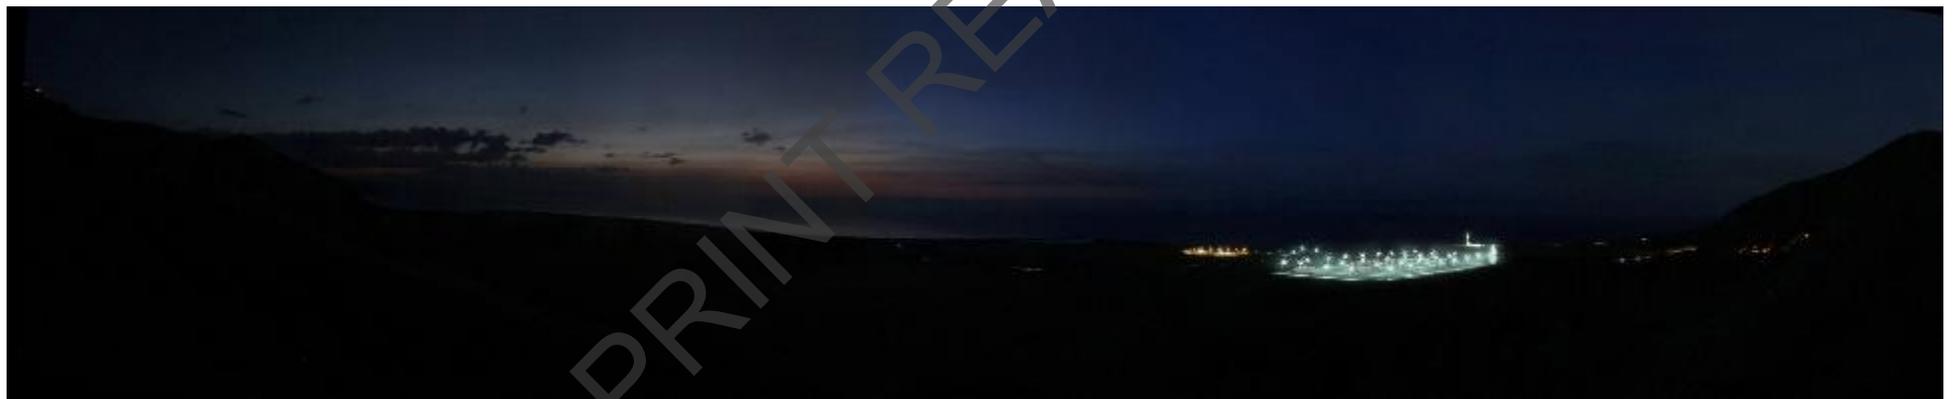
Figure 23: Night-time panoramic view of the peninsula and production site from the southeast along the escarpment, before (top) and after (bottom) construction of the project infrastructure

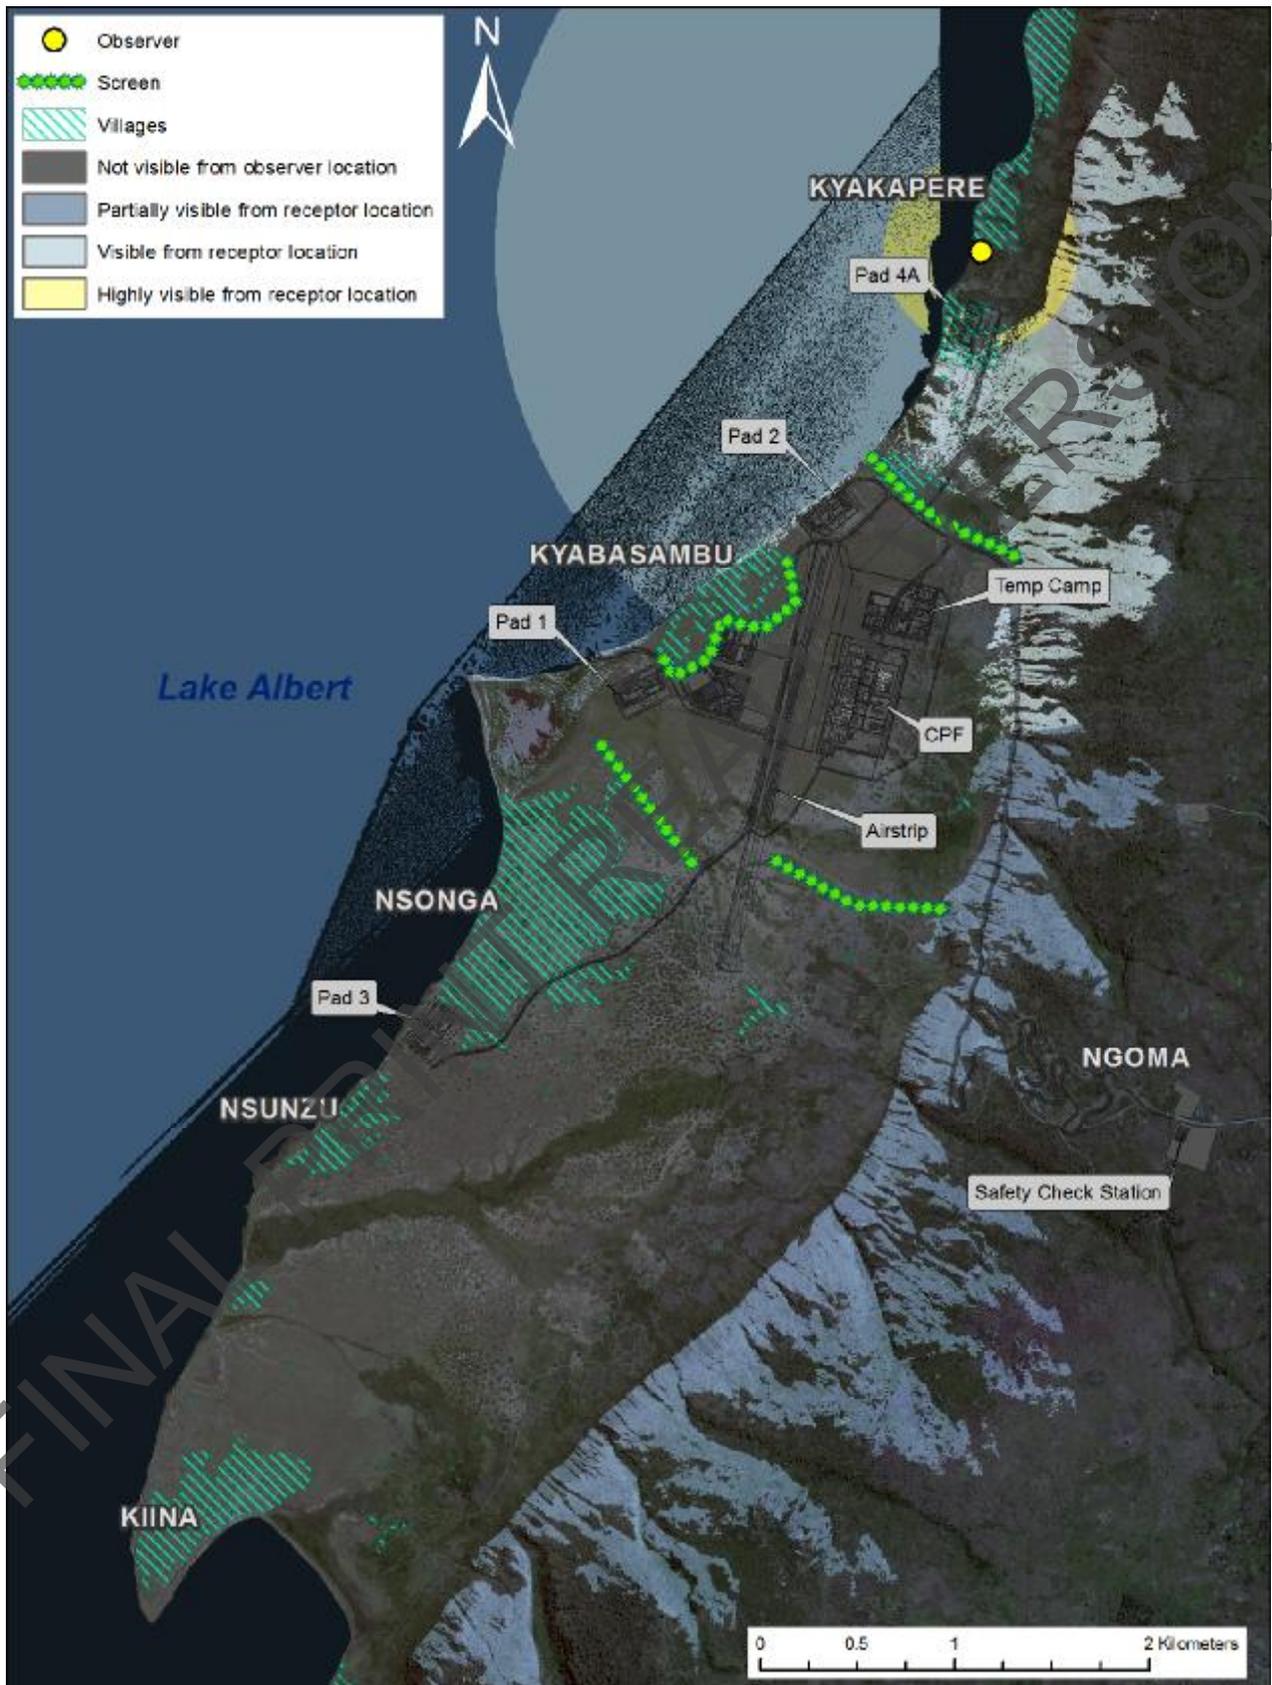
Figure 24: Visibility of project infrastructure from Kyakapere village (receptor-based viewshed) after visual screening

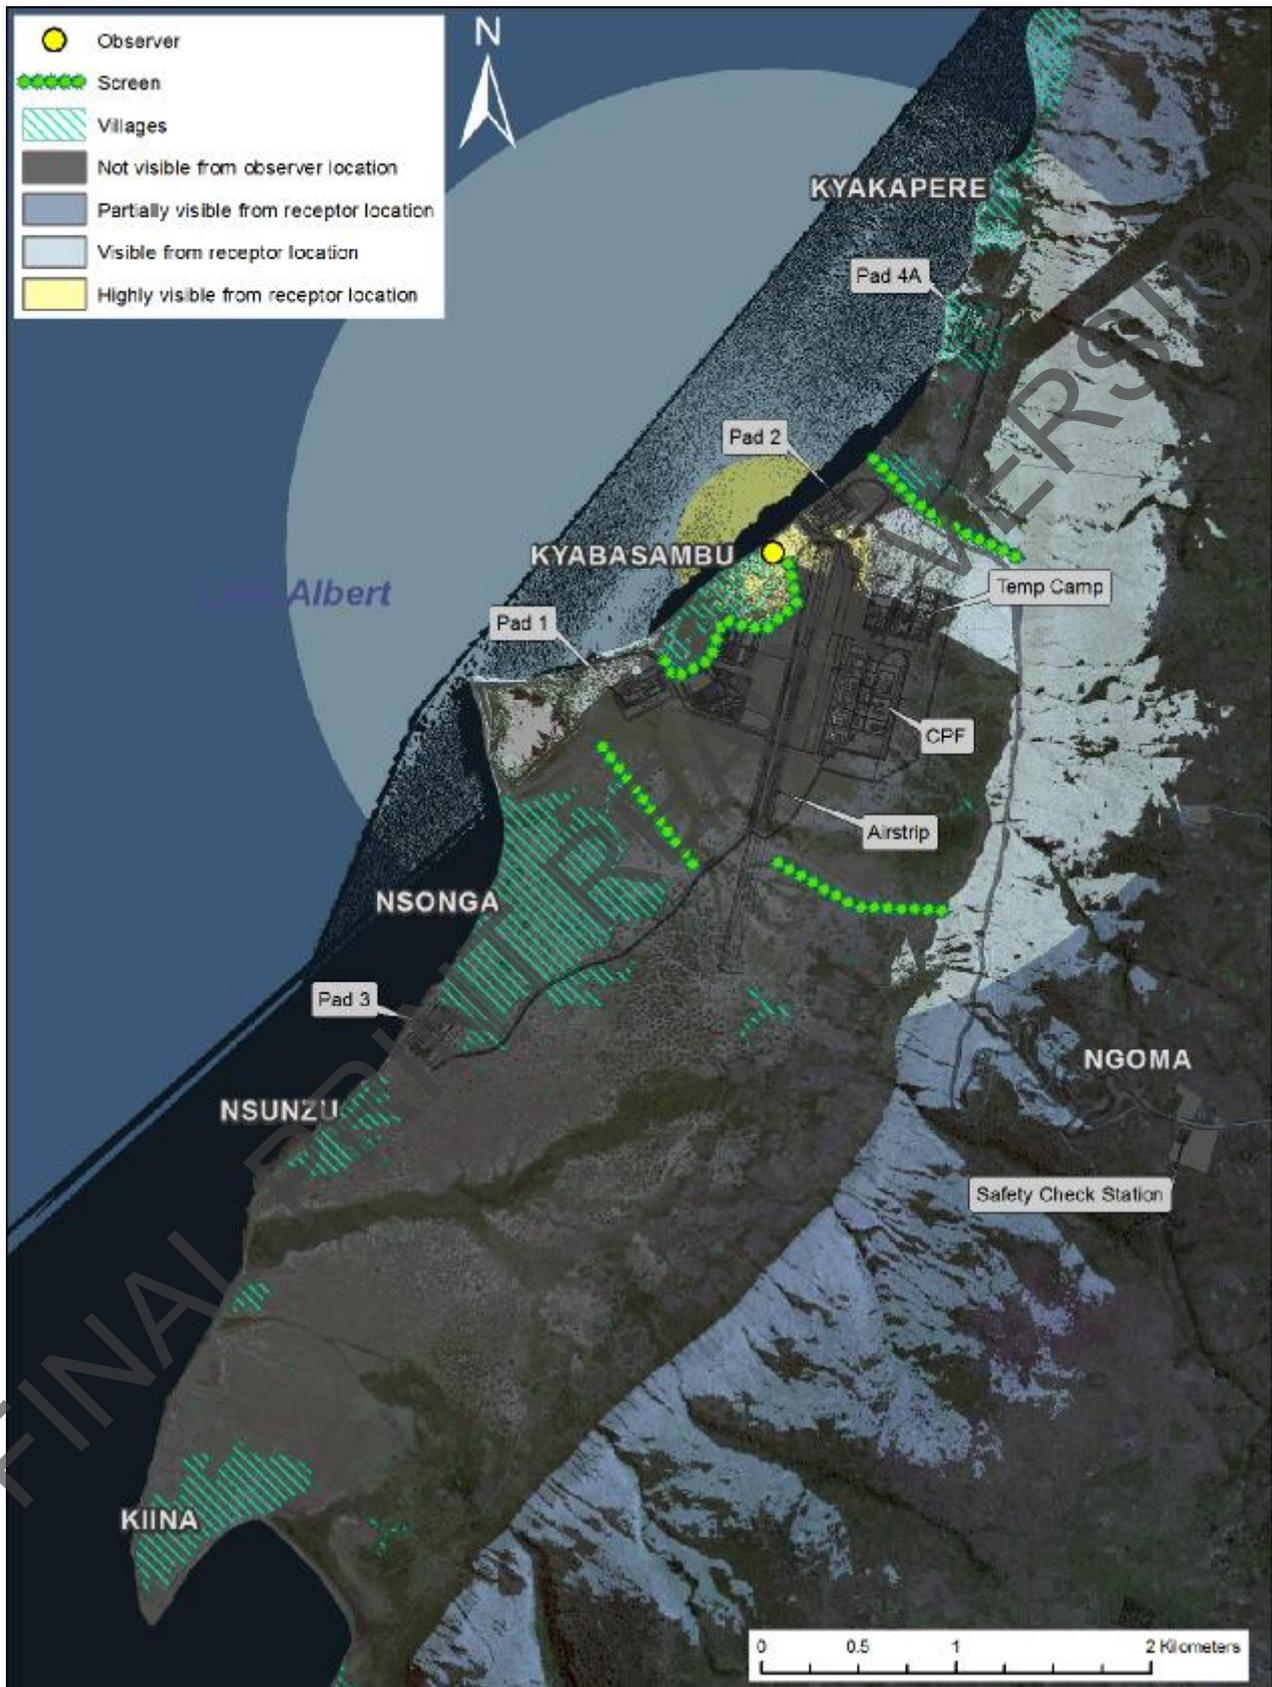
Figure 25: Visibility of project infrastructure from Kyabasambu village (receptor-based viewshed) after screening

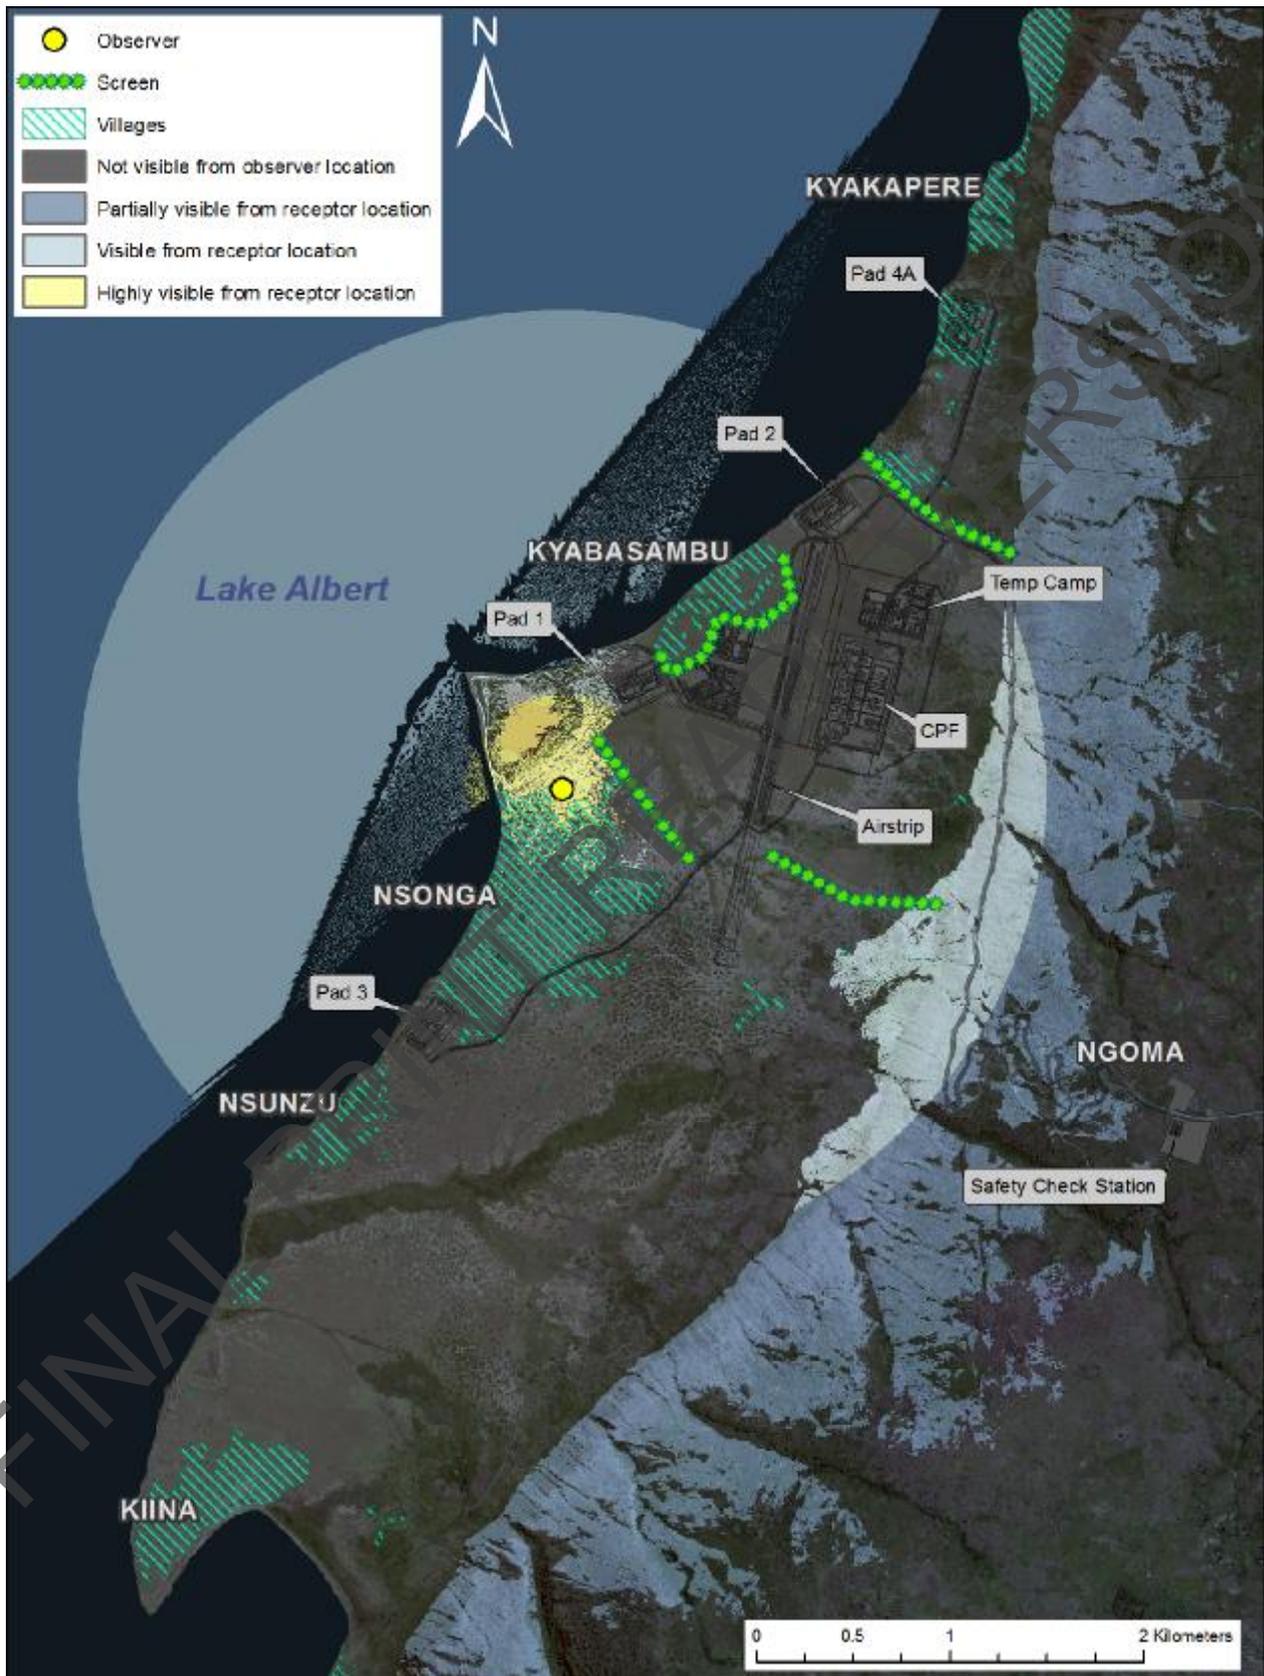
Figure 26: Visibility of project infrastructure from Nsonga village north (receptor-based viewshed) after screening

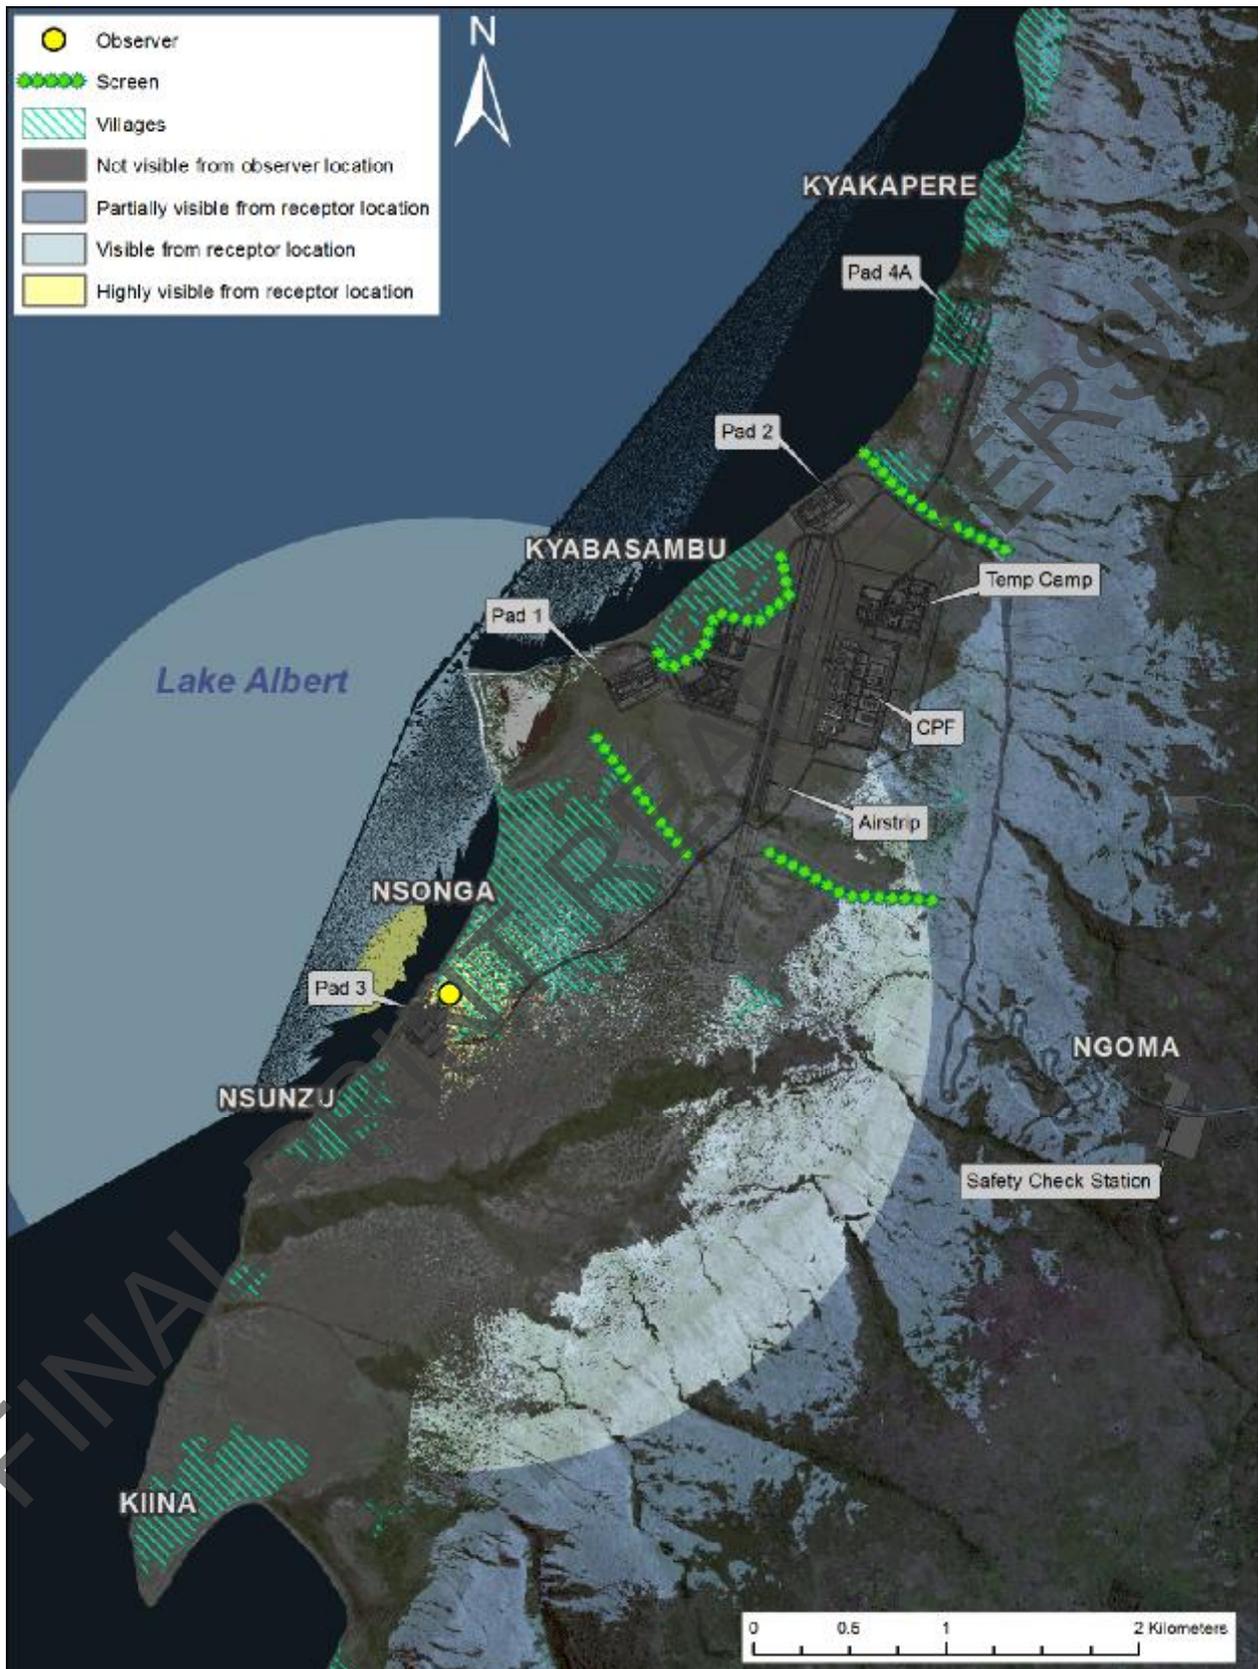
Figure 27: Visibility of project infrastructure from Nsonga village south (receptor-based viewshed) after screening

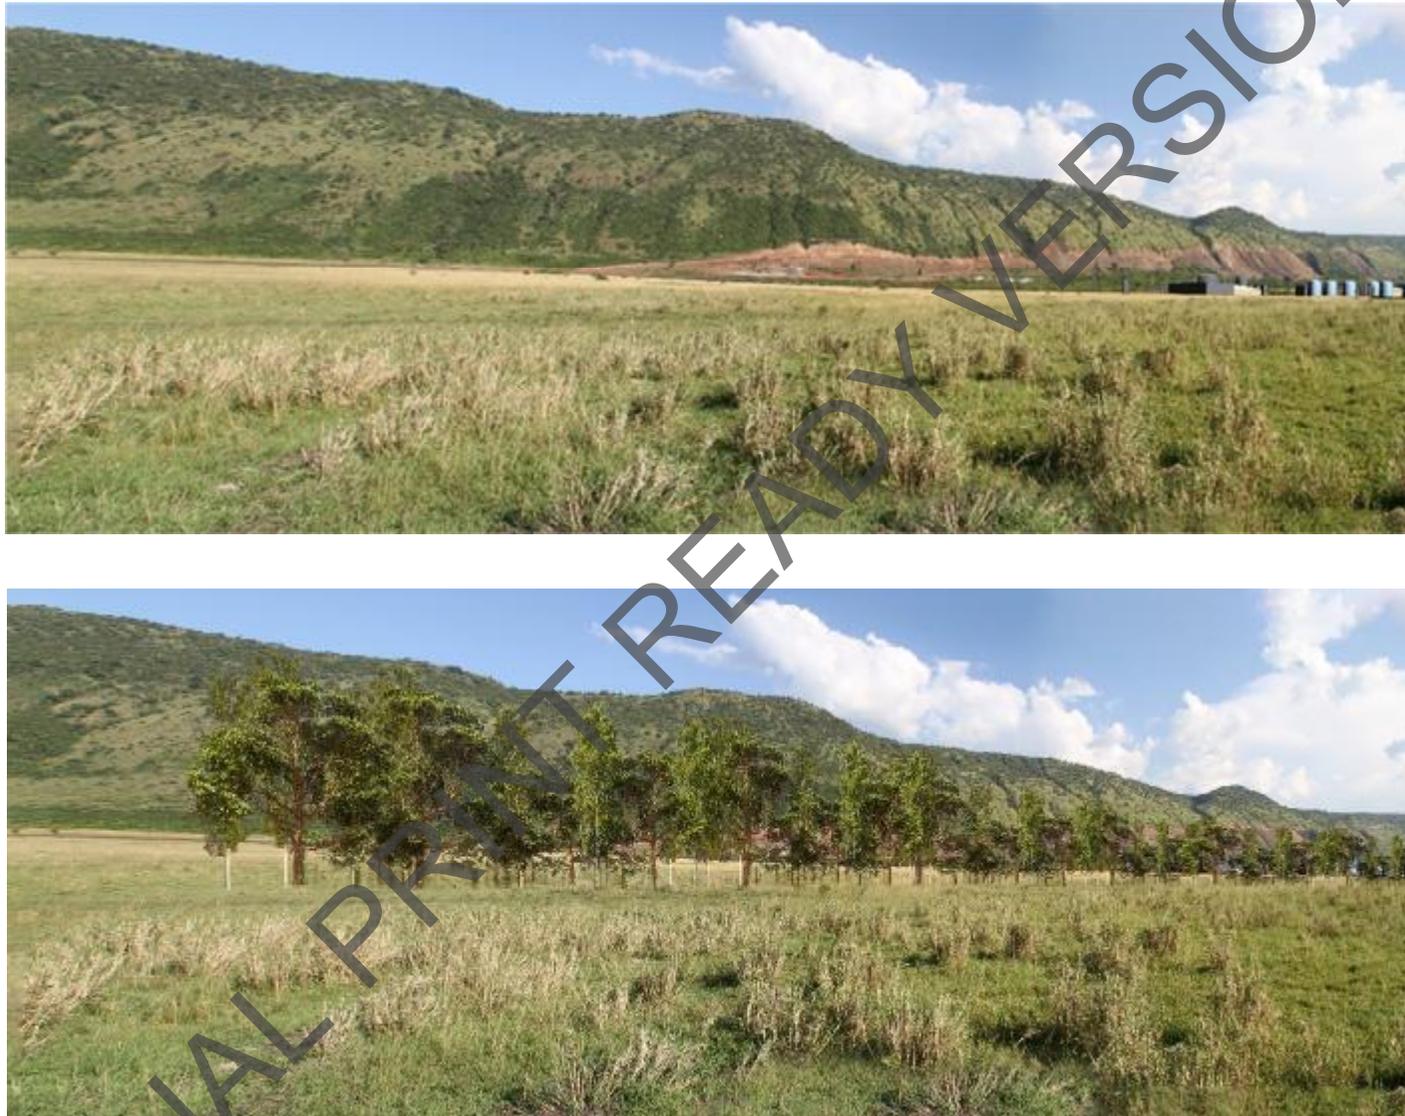
Figure 28: Daytime view of the CPF site from the northwest, before (top) and after (bottom) visual mitigation

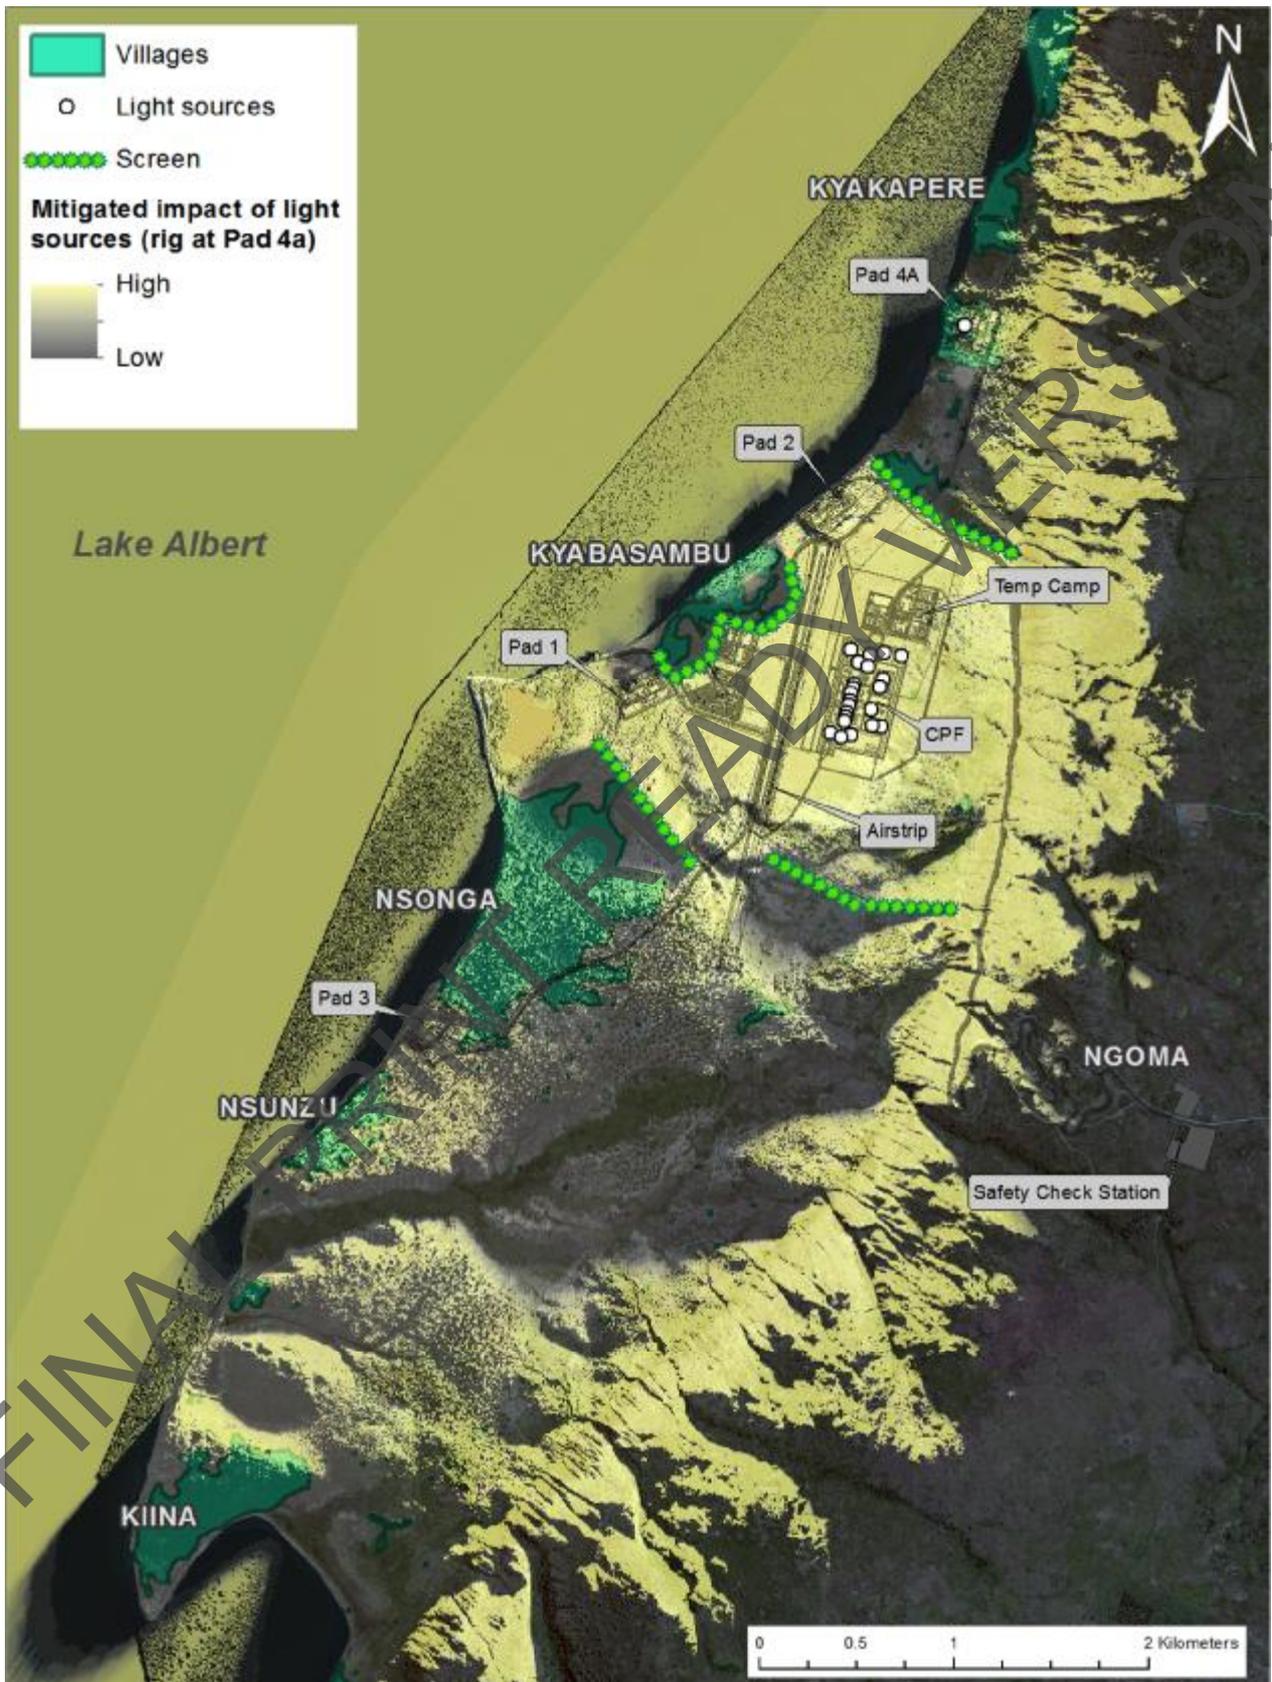
Figure 29: Night-time illumination (impactor-based viewshed) within study area for CPF and drill rig at well pad 4, after screening
