CNOOC UGANDA LIMITED

Visual Impact Assessment Report for the Proposed Kingfisher Development

Report Number: 1776816-321515-16

REPORT - VOLUME 4, STUDY 7

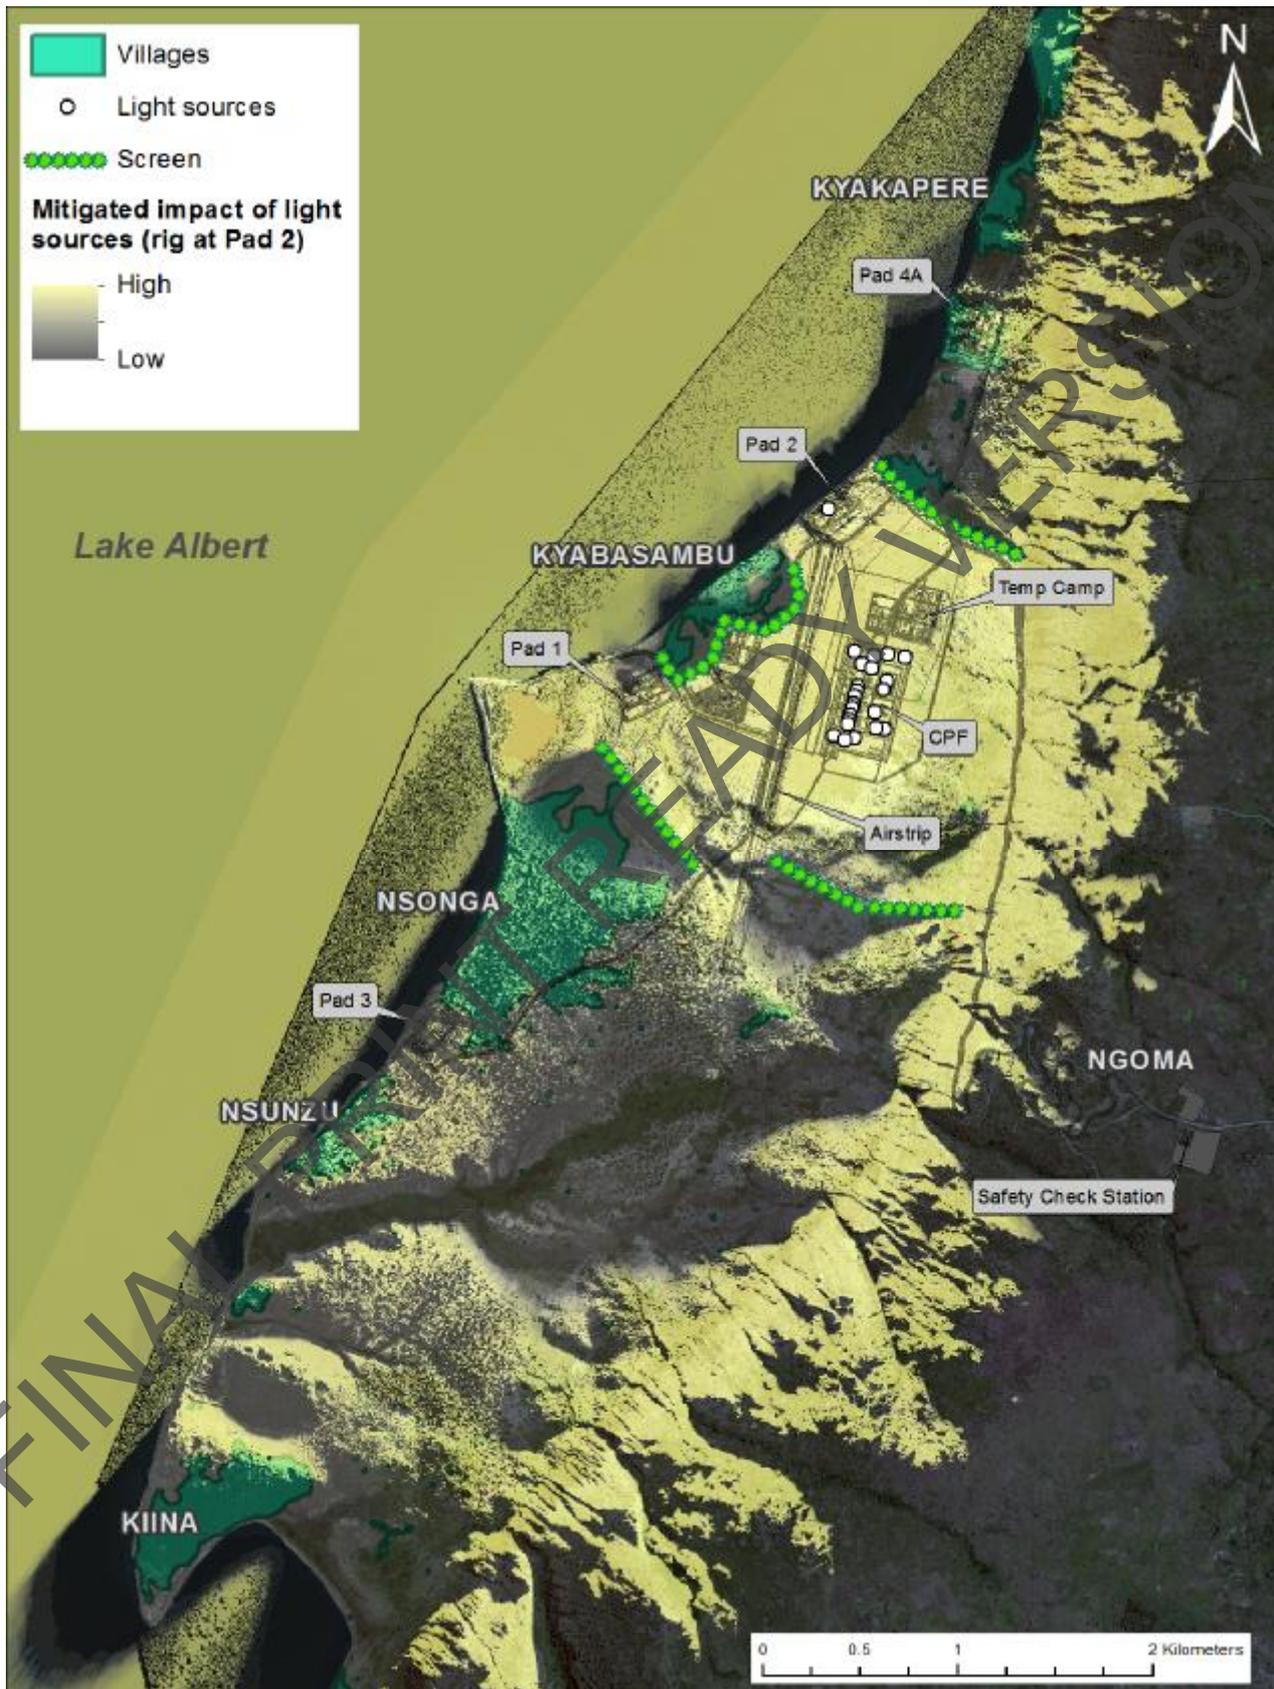
Figure 30: Night-time illumination (impactor-based viewshed) within study area for CPF and drill rig at well pad 2, after screening

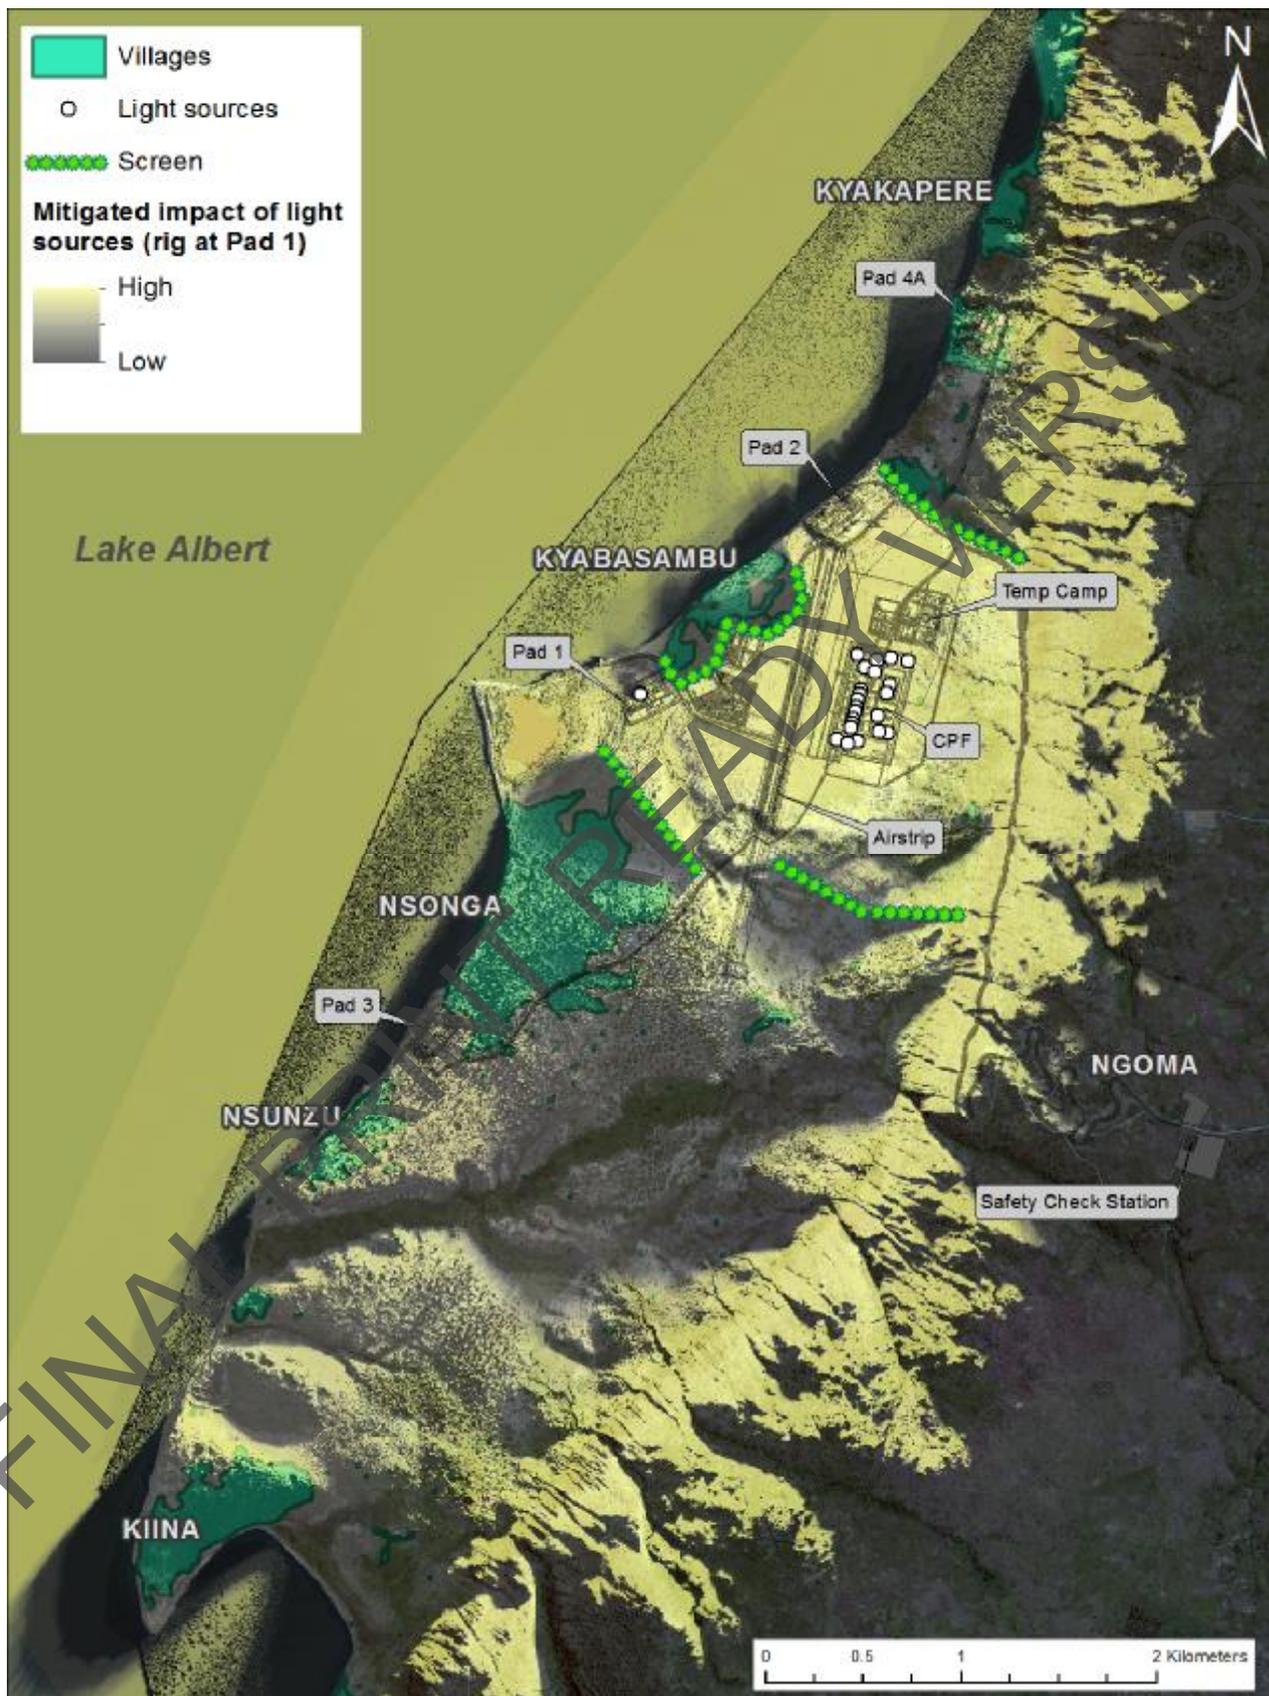
Figure 31: Night-time illumination (impactor-based viewshed) within study area for CPF and drill rig at well pad 1, after screening

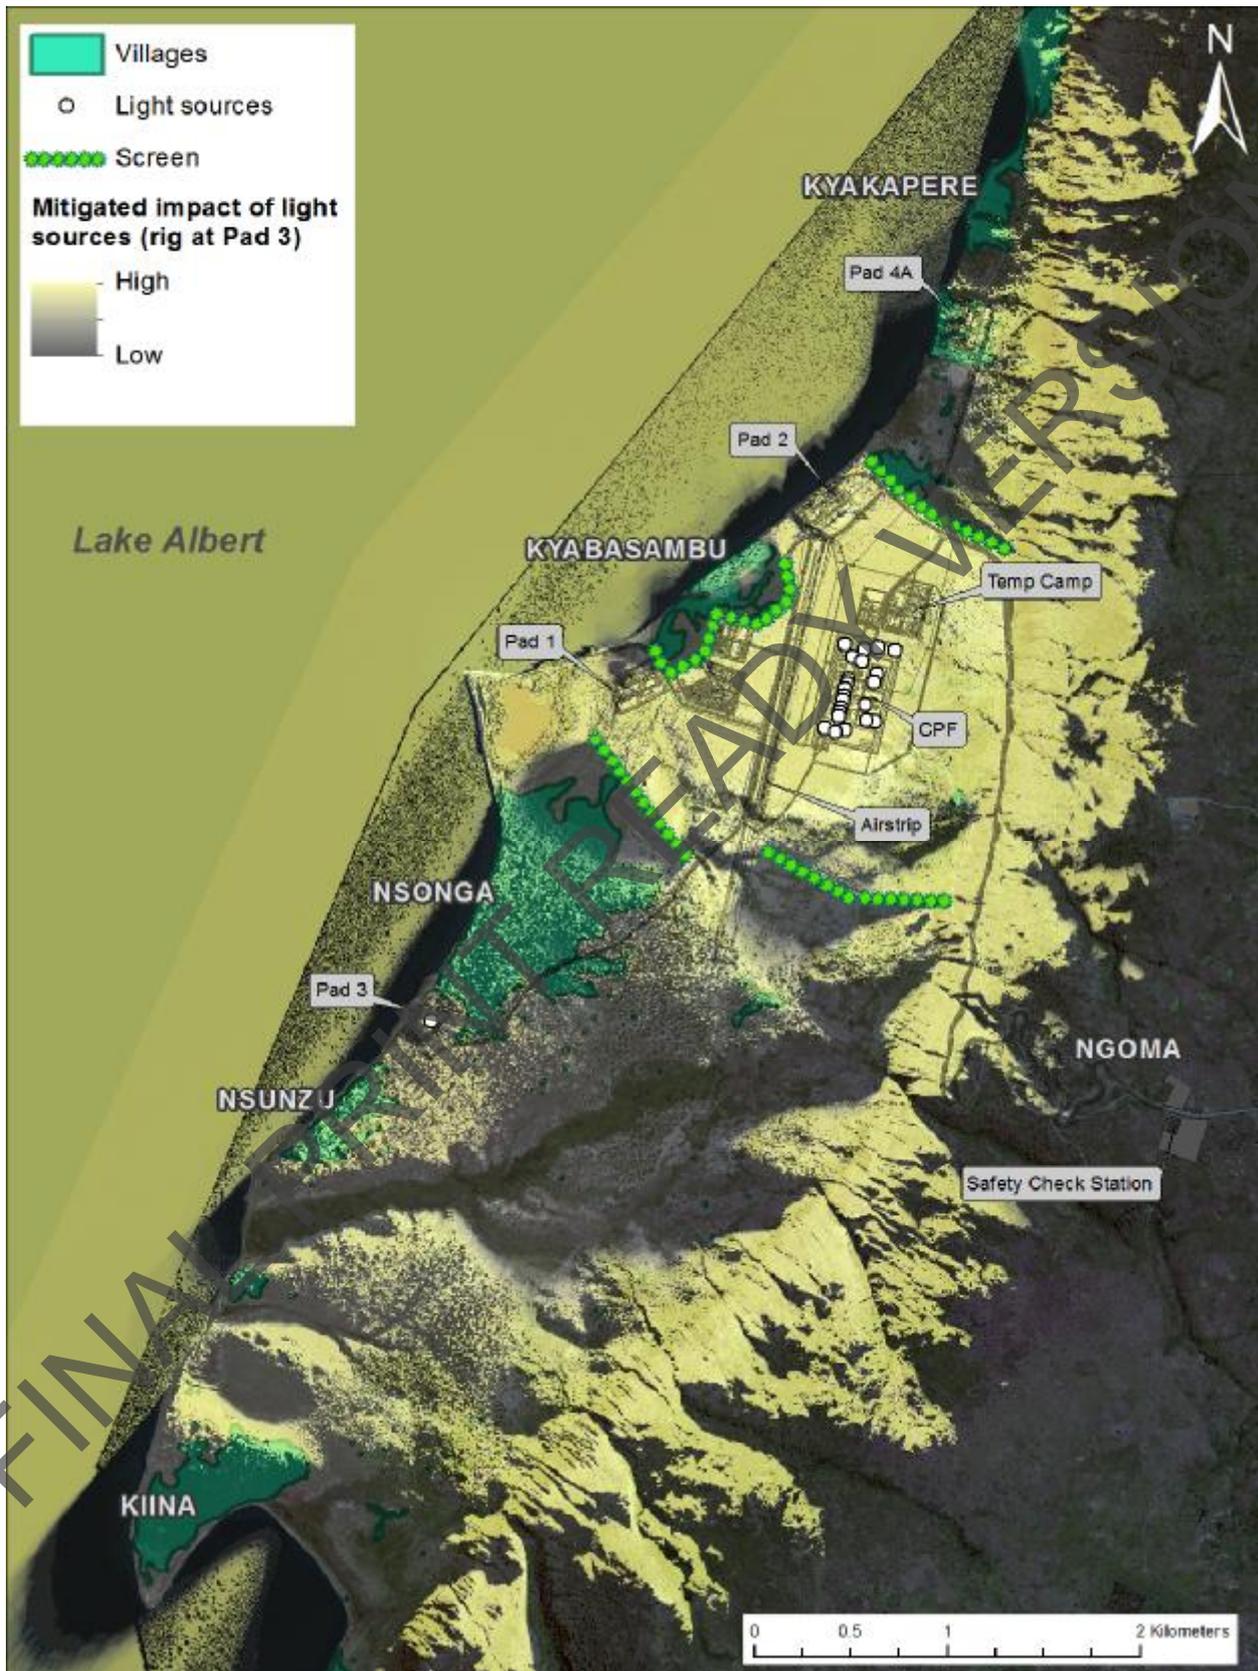
Figure 32: Night-time illumination (impactor-based viewshed) within study area for CPF and drill rig at well pad 3, after screening

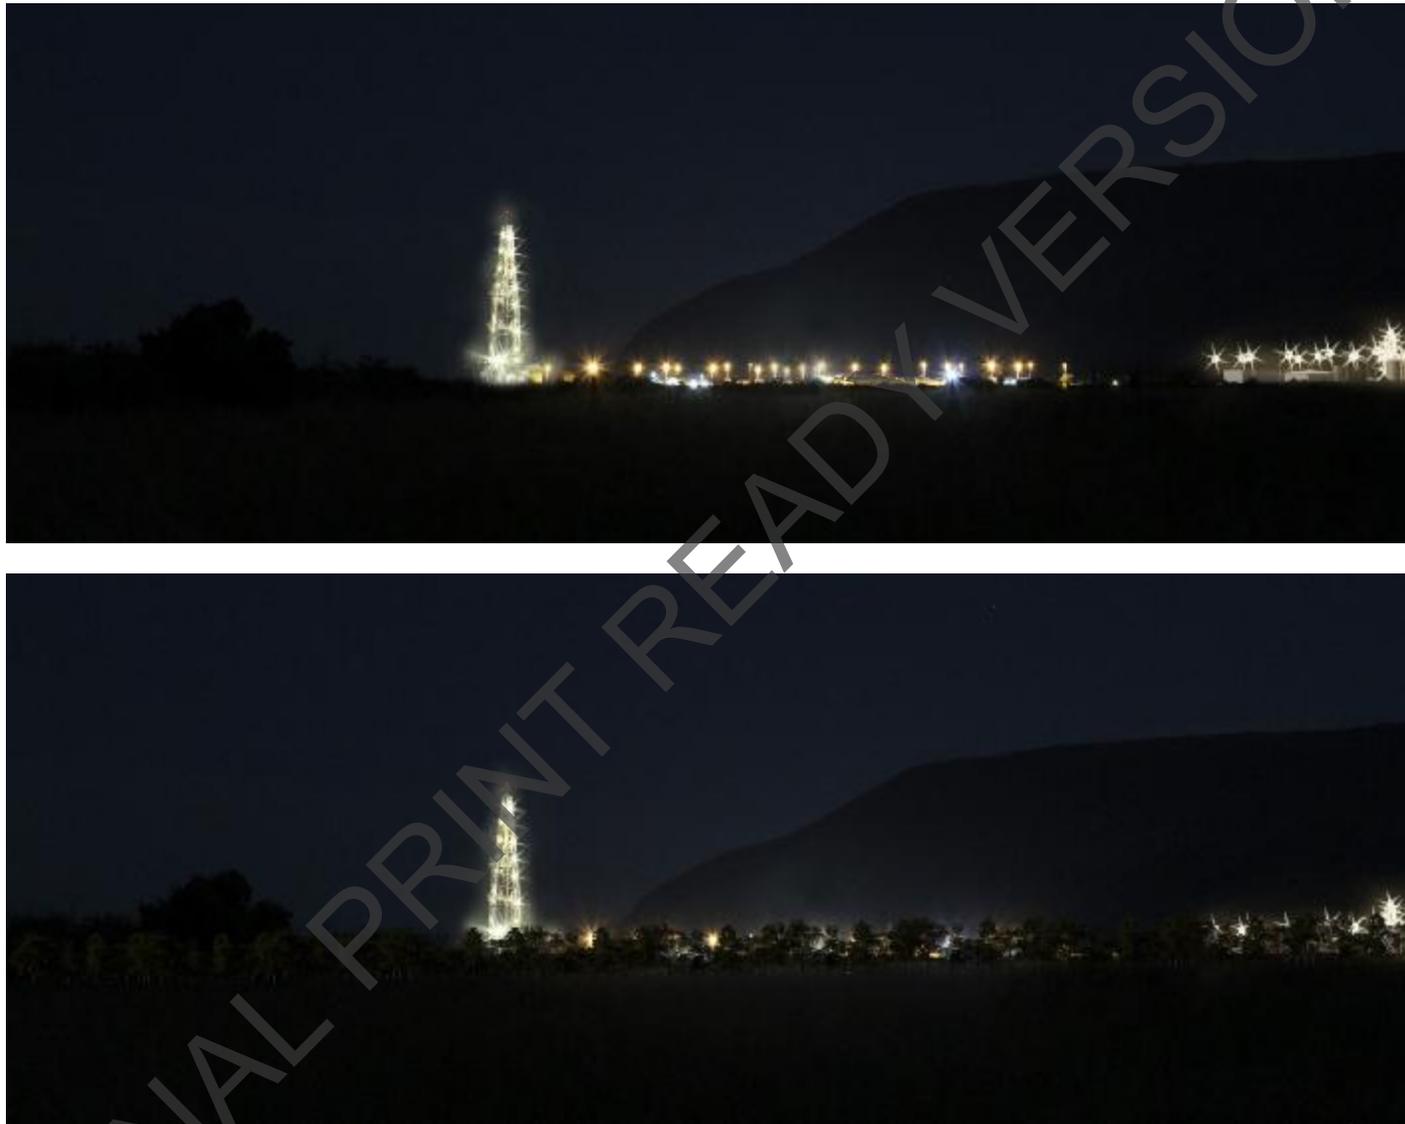
Figure 33: Night-time view of the permanent camp, CPF site and drill rig at well pads 1, before (top) and after (bottom) implementation of screening

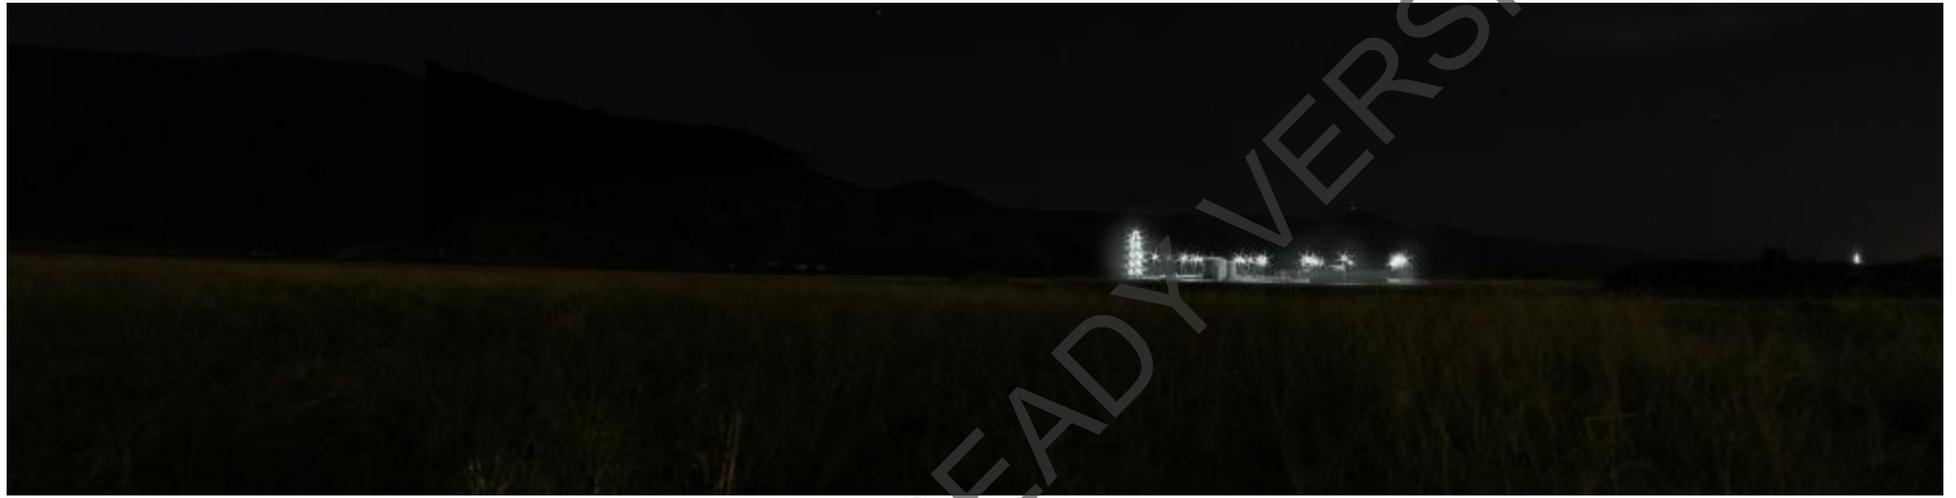
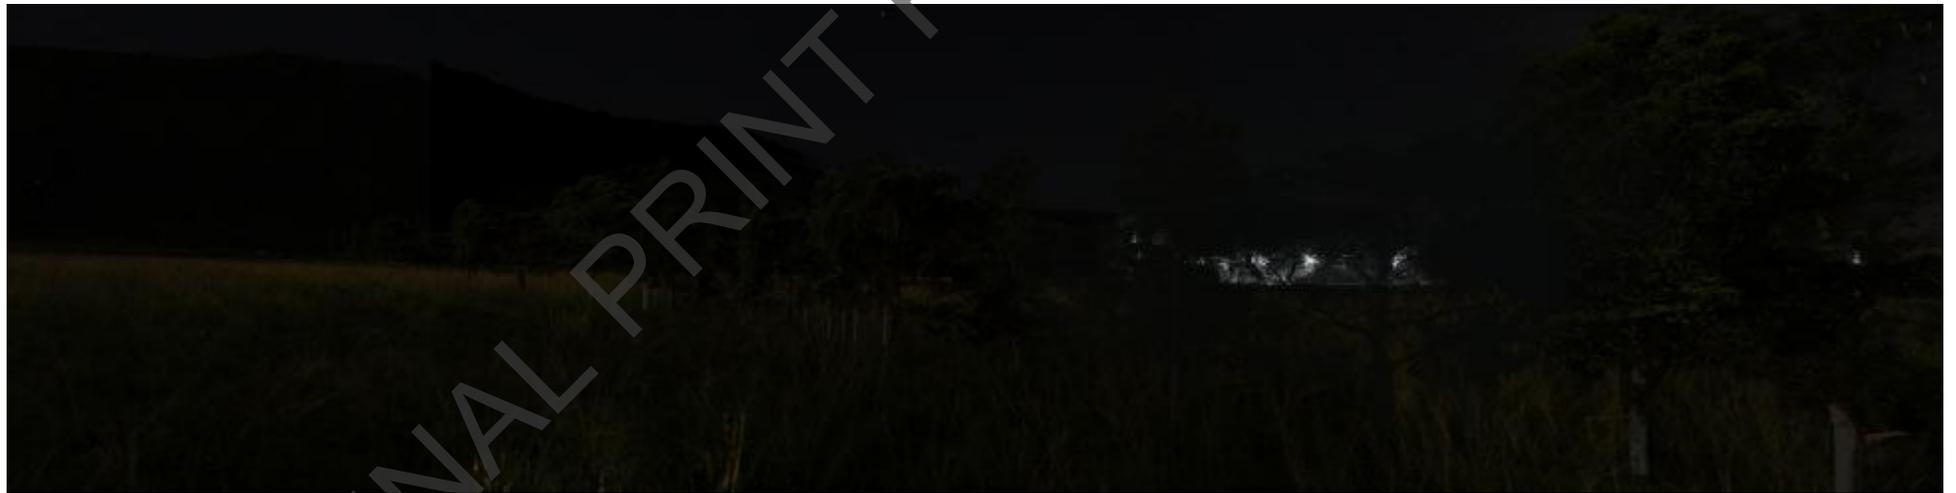
Figure 34: Night-time view of the CPF site from the northwest, before (top) and after (bottom) implementation of screening

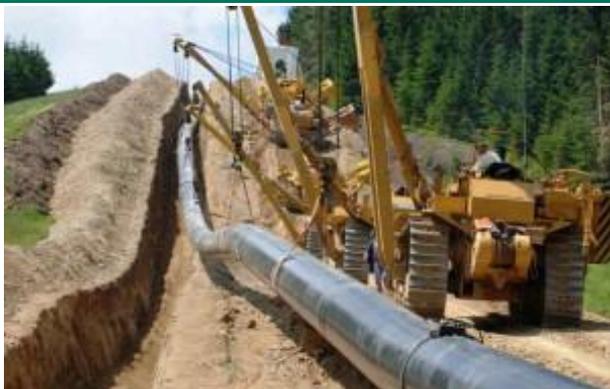
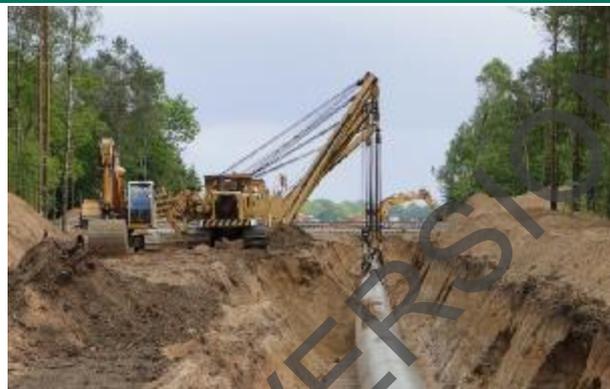
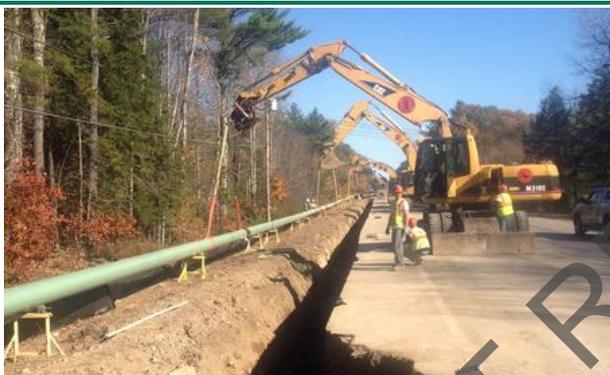
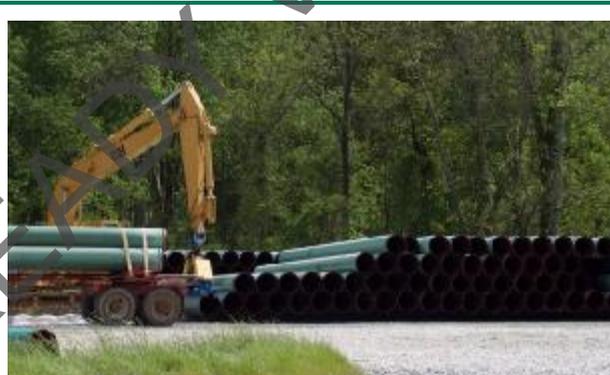
Positioning and lowering of a pipeline along an existing servitude/clearing through a wooded area

Final placement of a pipeline along a newly created corridor through a wooded area

Positioning of a pipeline within a servitude using an existing road as access way

Temporary pipeline and material laydown area

Figure 35: Typical construction related activities and visual impacts associated with the construction phase of a large pipeline project (images Wikipedia, 2017; CCPipeline, 2017)

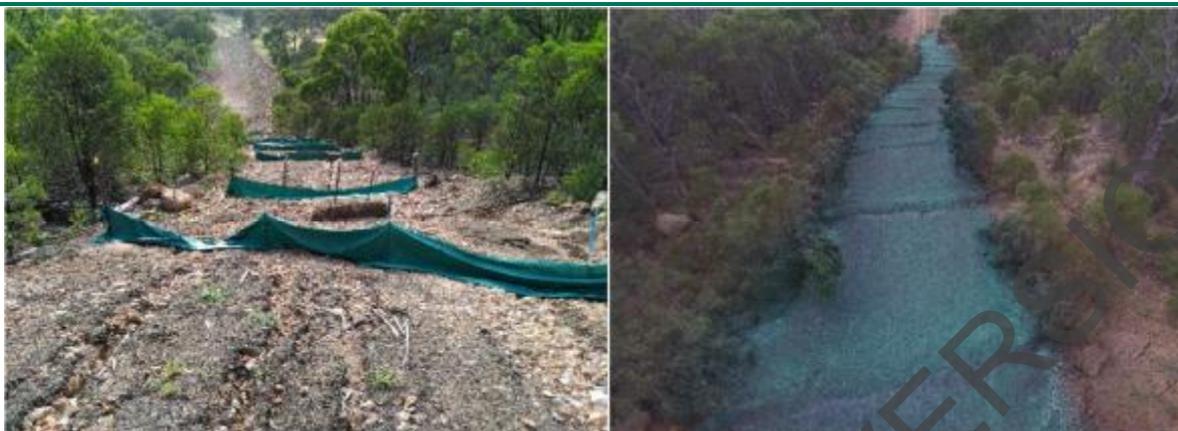
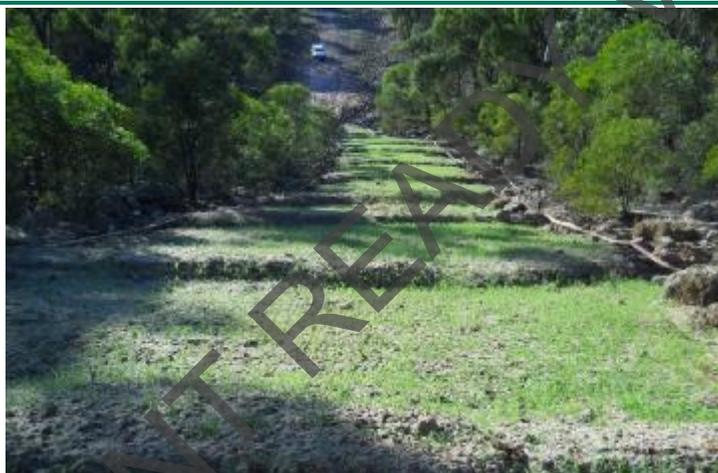
Initial backfilled pipeline corridor along a steep embankment protected against erosion with mulch and sediment netting (left) and subsequently soil binding polymers (right)

Corridor re-vegetated with grasses and stabilised with erosion-prevention structures, which will in time be re-colonised with suitable tree species (images Beneterra, 2017)

Figure 36: Rehabilitation of a backfilled pipeline corridor

The bulk of visual mitigation must focus on reversing the visually intrusive and unsightly effects of the construction process, by rehabilitating the closed-up sections of the pipeline trench and access roads as quickly as possible. Specific rehabilitation activities will be highly site-specific, however Figure 36 illustrates a typical sequence of rehabilitation activities in this regard.
